Walkway collapse at

PORT RAMSGATE

A report on the investigation into the
walkway collapse at Port Ramsgate on 14
September 1994

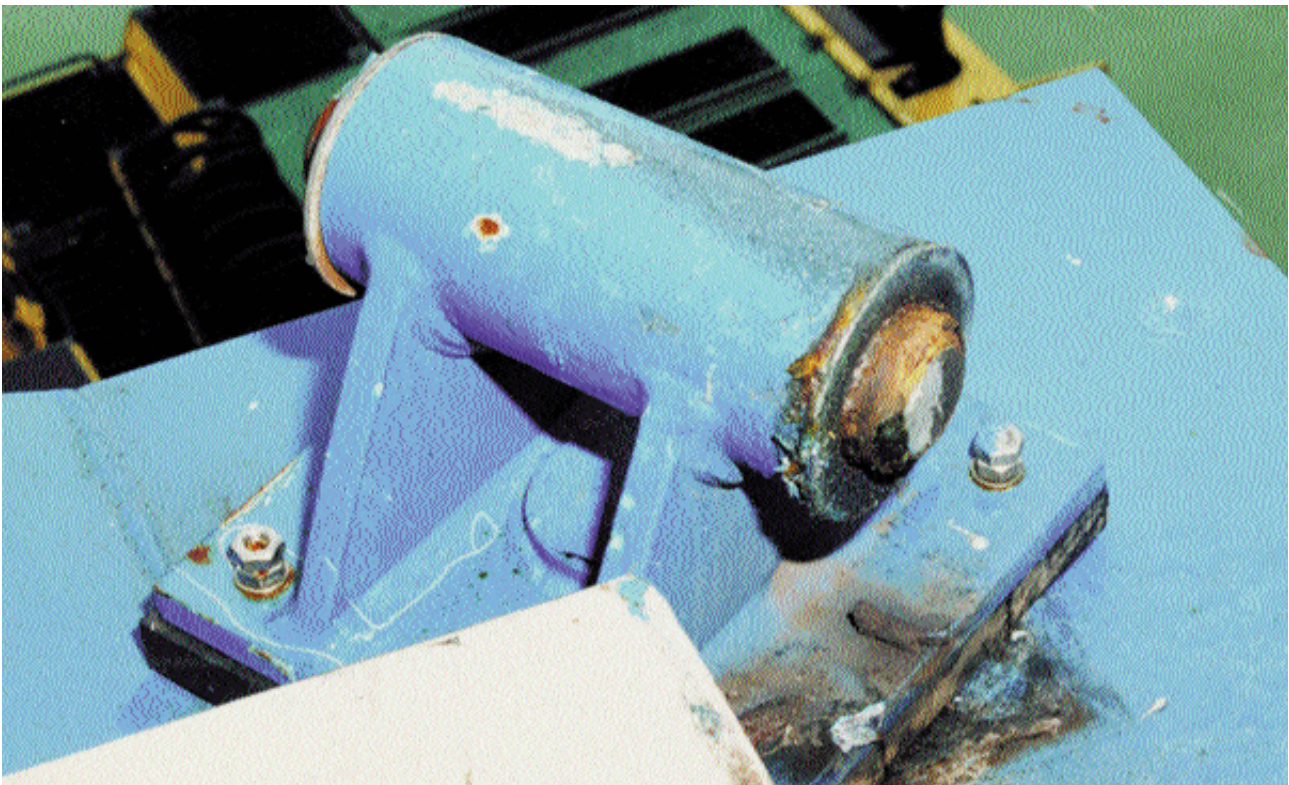
Figure 14: Seaward right support foot as found

- 45 Following the accident, the seaward right support foot was still connected to the support platform by the vertical pin/pintle. It was found rotated at an angle of approximately 45° about its vertical axis, suggesting that it had been pulled into this position as the walkway moved towards the edge of the platform. The broken-off stub axle protruded from the support foot and the fracture surfaces on the axle and collar were dark and rusted over much of their surface. A recent indentation/burr in the support foot base plate immediately below the end of the stub axle was the only other obvious damage. This 'notch' suggested contact with the edge of the disconnected walkway. Figure 14 is a photograph of the seaward right support foot following the accident. Figure 16 shows the collar to which it had been welded.

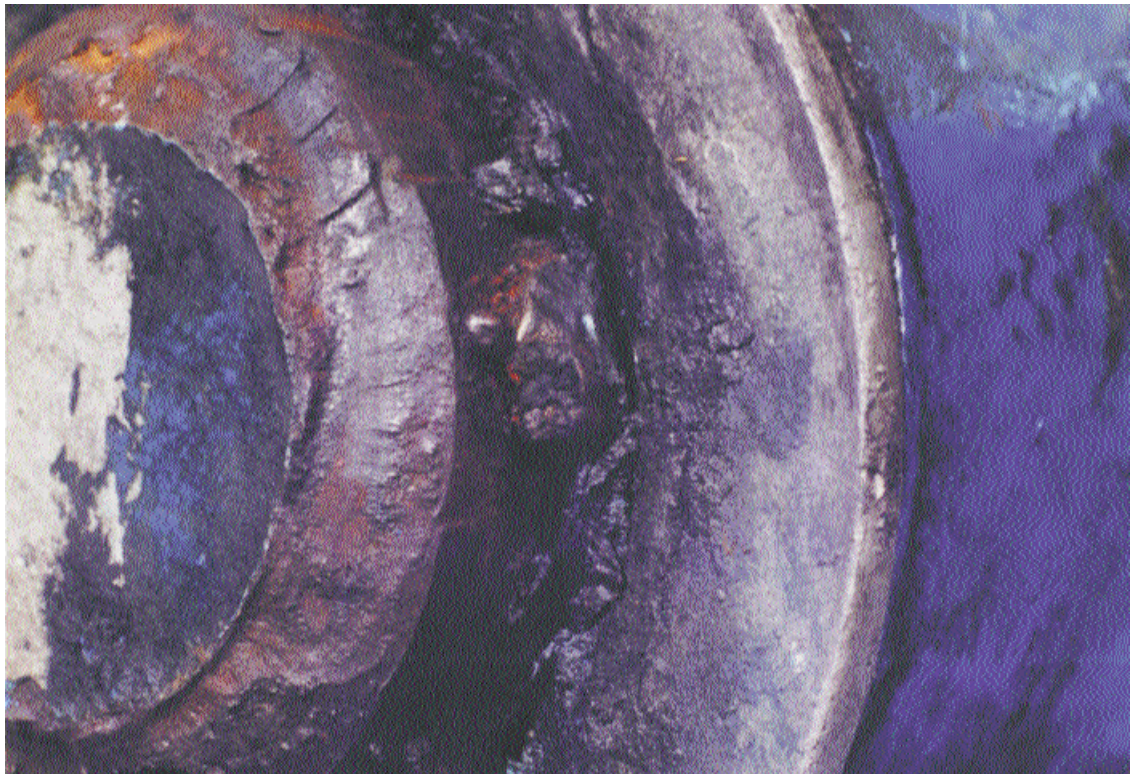
Figure 15: Seaward right stub axle - fracture surface - seized in support foot

- 54 Photographs were taken before cleaning and dismantling work at HSL. Figure 15 shows the seaward right stub axle protruding from its support foot and Figure 16 is the corresponding seaward right collar. Figure 19 shows the seaward left stub axle protruding from its support foot and Figure 23 is the corresponding seaward left collar.

- 56 The seaward right stub axle welds (this being the support with the pintle) had completely separated some time - possibly days - before the accident. The seaward left stub axle welds had failed around much of their circumference by fatigue cracking, with the final ligament of attachment breaking during the accident. Because the stub axles were made of medium carbon steel, they required a special welding procedure including preheating of components before welding and heat treatment after welding. None was used. The welds were of very poor quality and contained many defects including:

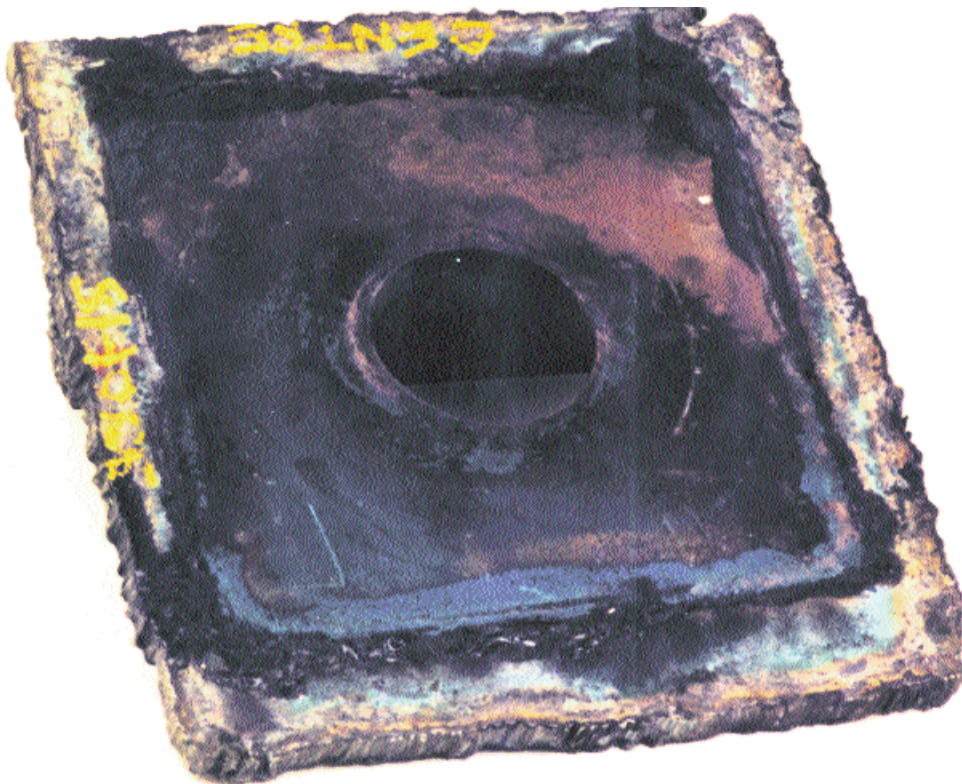
Figure 17: Seaward right support platform after dismantling and removal of seaward right foot

allow for pontoon movement. The painted finish below the low-friction contact area was also much worn away and the base metal rusted, especially on the seaward edge of the contact zone. Figure 18 is a photograph taken the day after the accident, showing the top left contact area of the support platform.

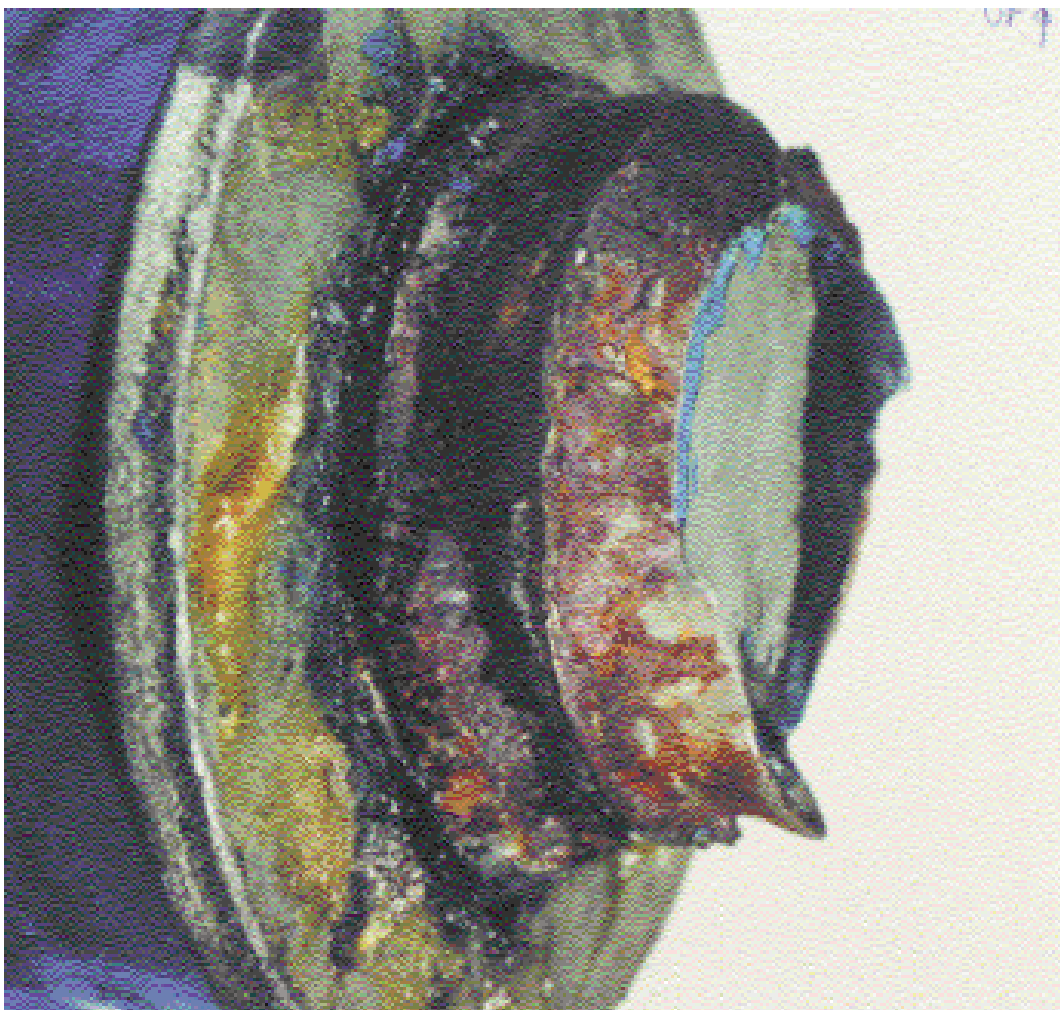
Figure 20: *Seaward left stub axle - fracture surface - partially seized in support foot*

- 50 The seaward left stub axle was seized within the support sleeve. Figure 19 shows the failed seaward left stub axle protruding from its support foot. Dismantling required machining the support sleeve into two pieces to free the stub axle. The grease distribution groove at the bottom of the sleeve bore was found to be completely blocked with rust and metal debris. Despite its immersion in sea water, it is likely that the seaward left support foot was not rotating on its stub axle before the accident.

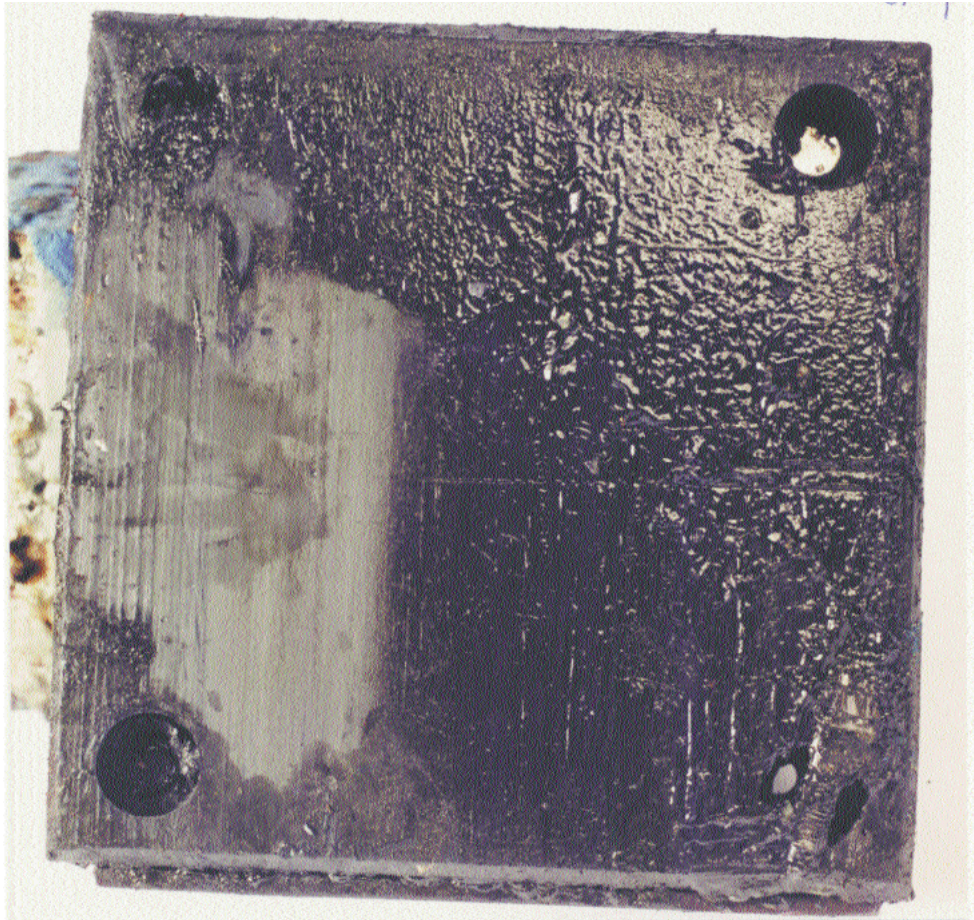
The underside of the pad was coated in grease apart from a dry area extending across the inner third of the pad. This area was scored by sliding contact with the slideway. Figure 21 shows these features.

Figure 21: Shore end right support foot - underside of low-friction pad

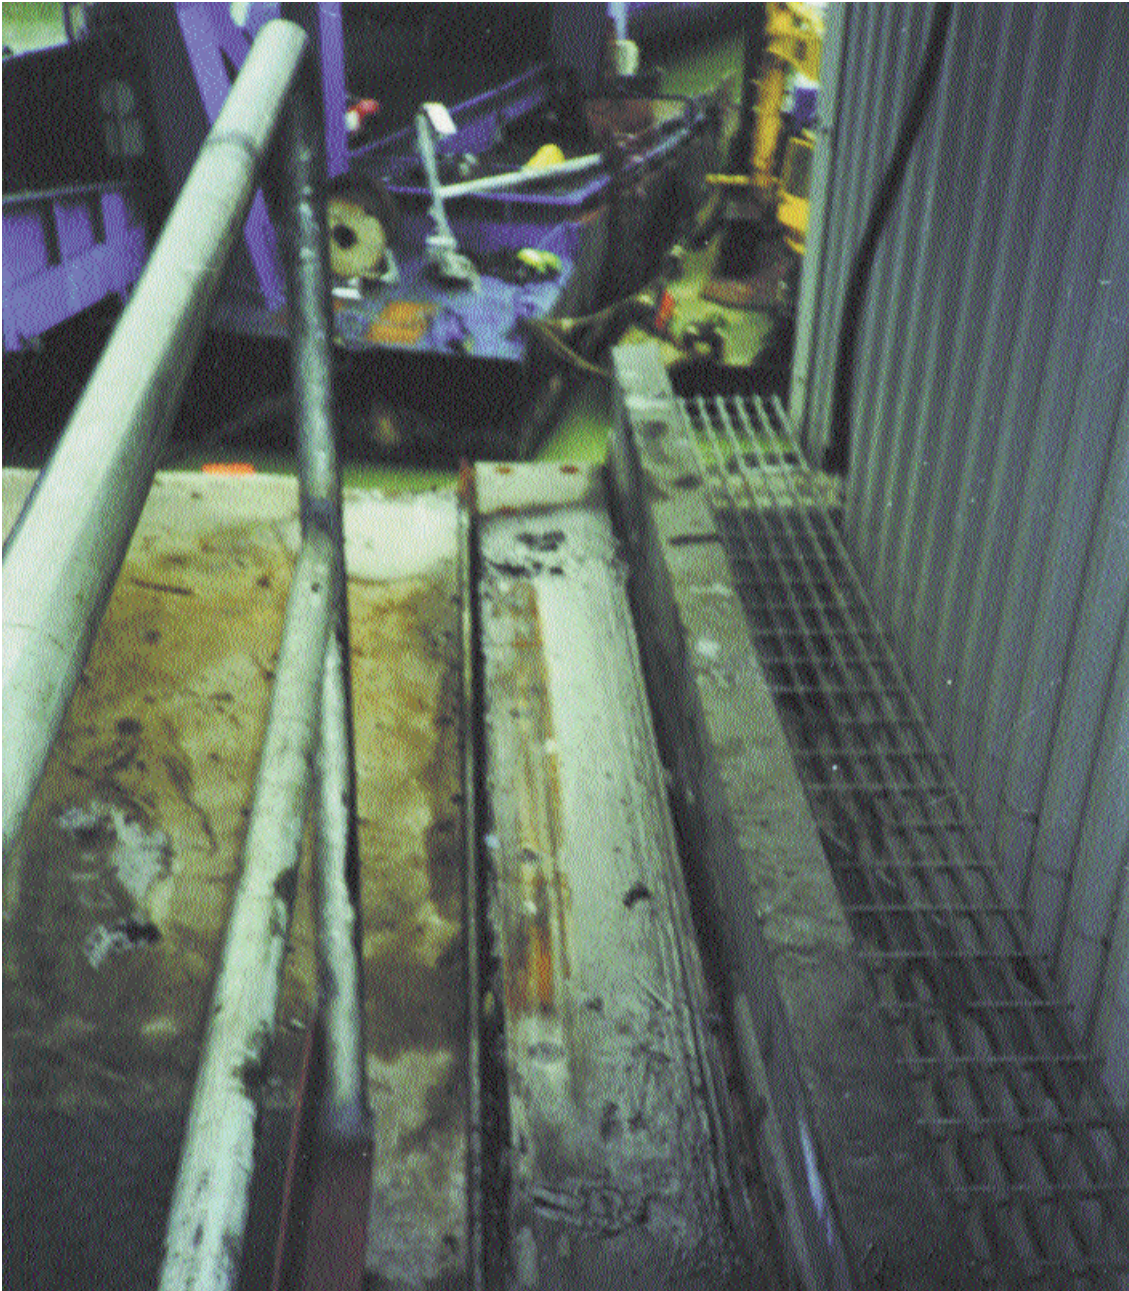
- 53 The 'U' channel slideways fitted in the passenger ramp building were photographed and examined but not removed. The sliding surfaces had grease on them and build-up of grease and debris less than 500 mm from the edge of the building indicated the seaward limit of recent sliding action. The slideways had been galvanised but both sliding surfaces had areas free from grease where rusting had occurred. This extended from their inner sides across approximately one-third of their width. The right-hand slideway was visibly in worse condition in this respect. The galvanising in these areas had been worn away. Figure 22 shows the right-hand slideway in the passenger ramp building.

Figure 22: *Right-hand slideway in passenger building showing rusting*

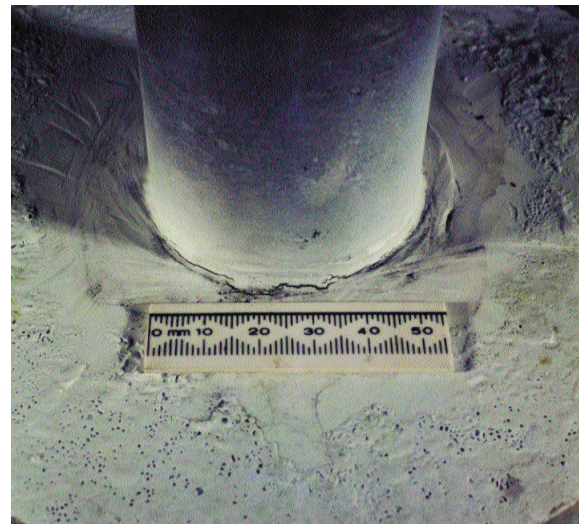
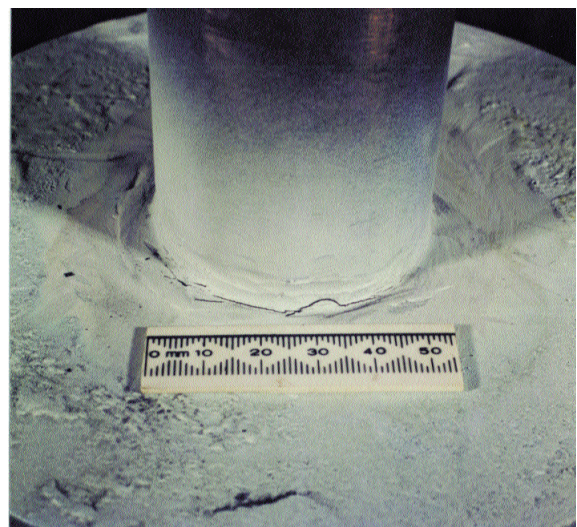
- 61 Although intact, the shore end stub axle to collar welds also had well advanced fatigue cracks. Figures 24 and 25 show the fatigue cracking

Figure 24: Shore end right stub axle/collar joint from below - fatigue cracks

Figure 25: Shore end right stub axle/collar joint from above - fatigue cracks

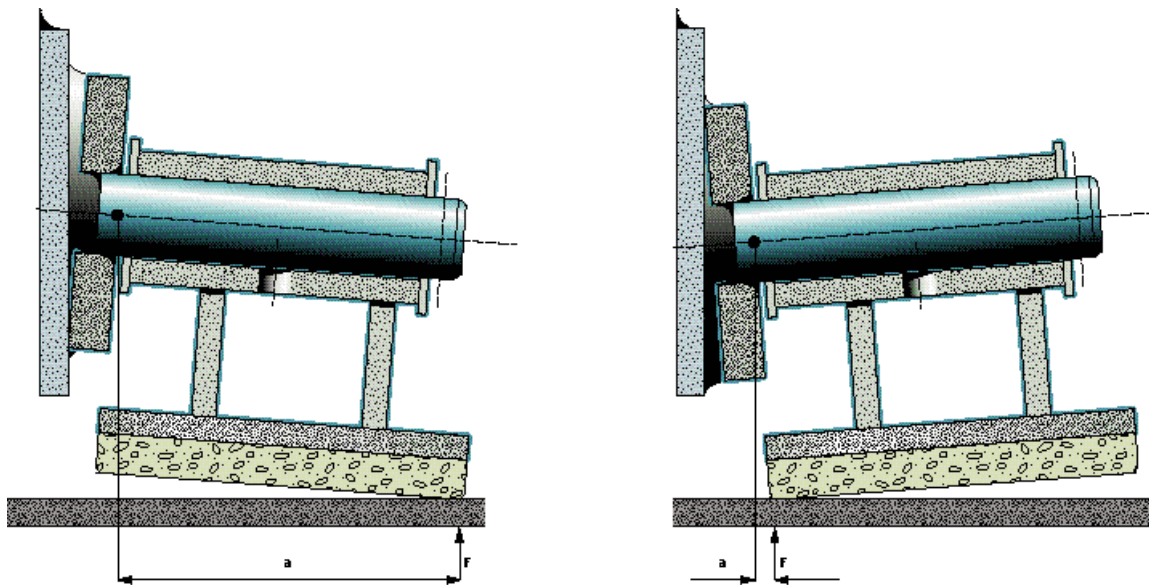
- (a) The design of the supports did not provide for roll of the pontoon.
- (b) At times, because the walkway was torsionally inflexible, it would be supported on just one foot at each end. This is referred to as 'two-foot support'.
- (c) Even if this fundamental design deficiency had not been identified, the design calculations should have assessed at least a reasoned 'worst case' option of the vertical load acting less than evenly on all four support feet.
- (d) A design relying on four welded, horizontal stub axles was going to be very susceptible to errors of stub axle and support surface alignment. This is illustrated in Figure 28.

Figure 28: Effect of stub-axle misalignment on bending arm moment - exaggerated to demonstrate principle

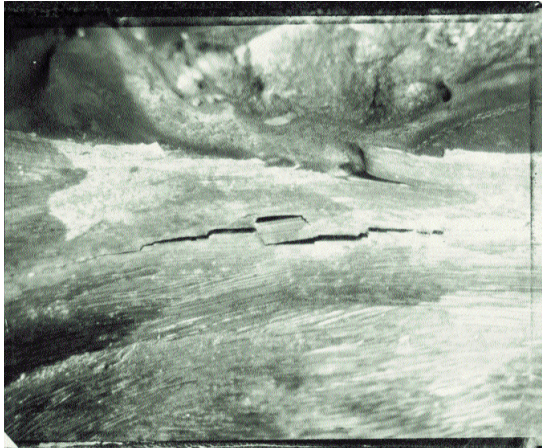
influenced by the presence of grinding marks on the outer surface - ie the cracks are all parallel to the grinding marks. Figure 31 shows an area of the external surface of the outer weld, where pre-existing cracks originating from grinding

Figure 31: Seaward left outer weld stub axle - fatigue cracks originating from grinding marks

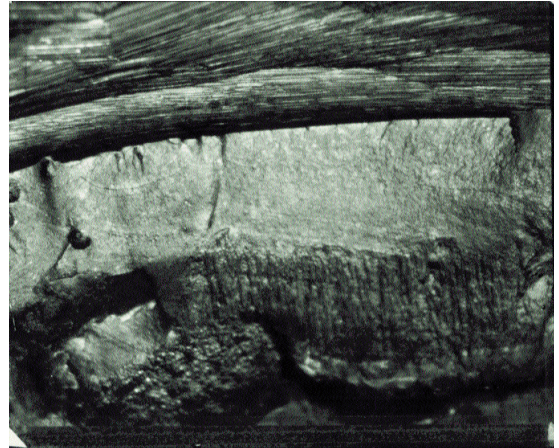
Figure 32: Seaward left outer weld stub axle - beach marks

On the fracture surface of the outer weld there are many areas where, under low magnification optical and scanning electron microscopy, beach markings are clearly visible. An example of these areas is shown in Figure 32. Beach marks are an important feature in identifying fatigue failure.⁵ They are a result of changes in the magnitude or frequency of loading, or of oxidation during periods of arrested crack development.

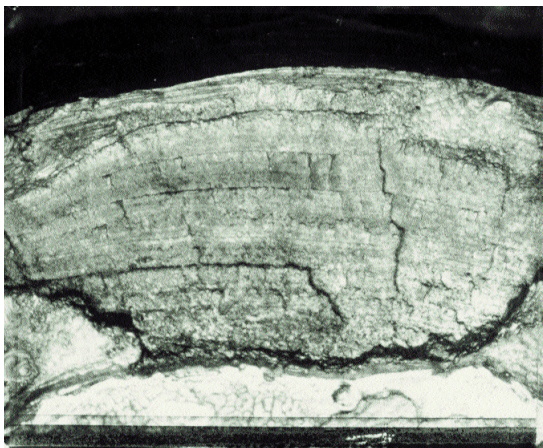
Figure 33: Seaward left inner weld stub axle - beach marks

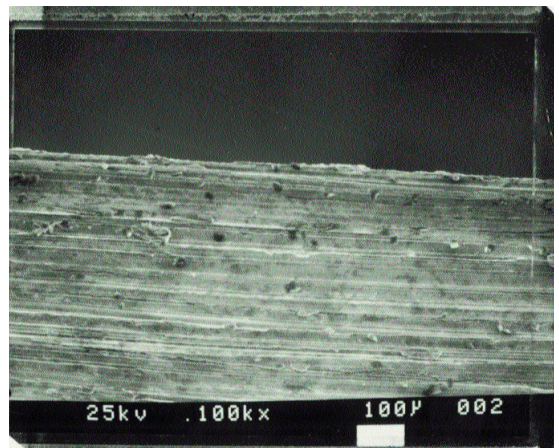
Figure 34: Seaward right stub axle - coincidence between grinding marks and fatigue cracks

- 10 Failure of the seaward right-hand foot assembly had also occurred as a result of the separation of the stub axle from the collar, which remained in position welded to the walkway structure. The failure on the stub axle is shown in Figure 15. The fractures were again at or close to the welds between the stub axle and the collar. Initiation of fatigue cracking of the outer weld was again closely associated with the grinding marks produced by the surface dressing operation. Multiple crack initiation sites were visible and the ratcheted nature of the fracture extended over a greater proportion of the outer weld surface than on the seaward left side. Only where there were other welding defects was this absent. There were no visual signs of overload failure in the outer weld. This indicates that it had been completely cracked by fatigue action before complete failure of the inner weld. Figure 34 shows the coincidence between grinding marks and the fatigue cracks.

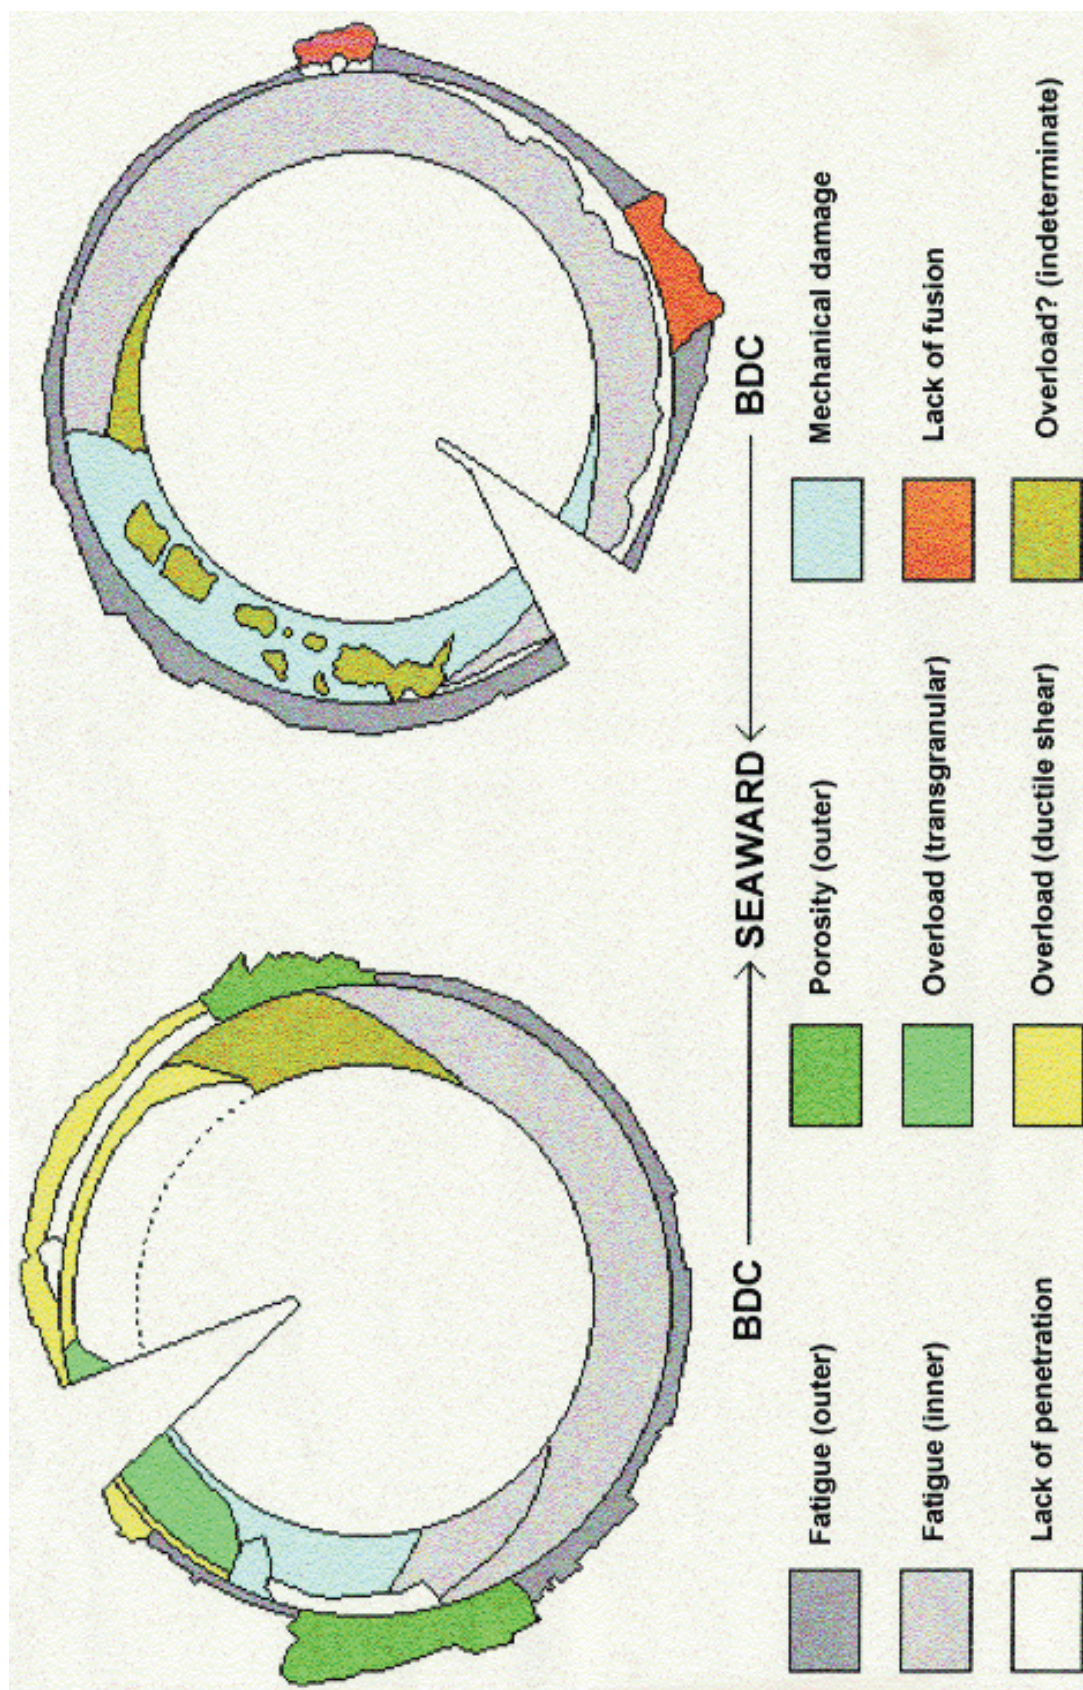
Figure 35: Schematic view of seaward left and seaward right stub axle fracture surfaces showing failure modes

- 12 A schematic representation of the fractures of both seaward stub axles including modes of failure is given in Figure 35. The poor quality of the welding and the problems associated with welding to the medium carbon stub axle meant that propagation of the surface-initiated cracks was aided by welding defects, including intergranular cracking in the stub axle material. An example of intergranular cracking at the root of the inner weld is shown in Figure 36.

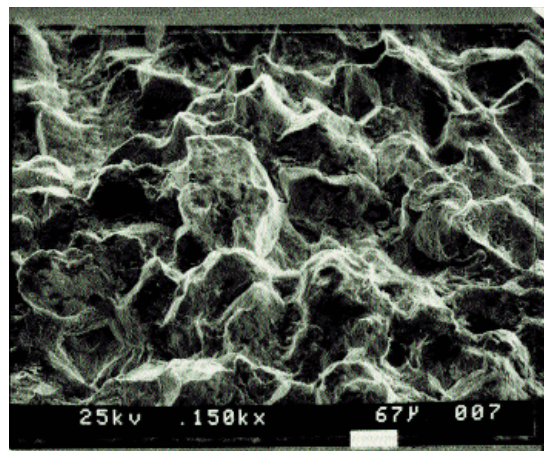
- 11 The inner weld had failed as a result of fatigue cracking followed by overload failure. The fatigue cracking was centred approximately 45° to shoreward of bottom dead centre in an area where there was significant lack of penetration of the weld metal to the root of the weld preparation. The fatigue cracking had propagated around approximately 75% of the circumference of the stub axle at which point overload failure occurred. None of the fracture surfaces, including the final overload region, appeared to be recent. The overload failure region had been quite heavily damaged by repeated contact between the fracture surfaces. Separation of the stub axle from the collar may have occurred several days before the accident.

Figure 36: Seaward right stub axle - interangular cracking at the root of the inner weld

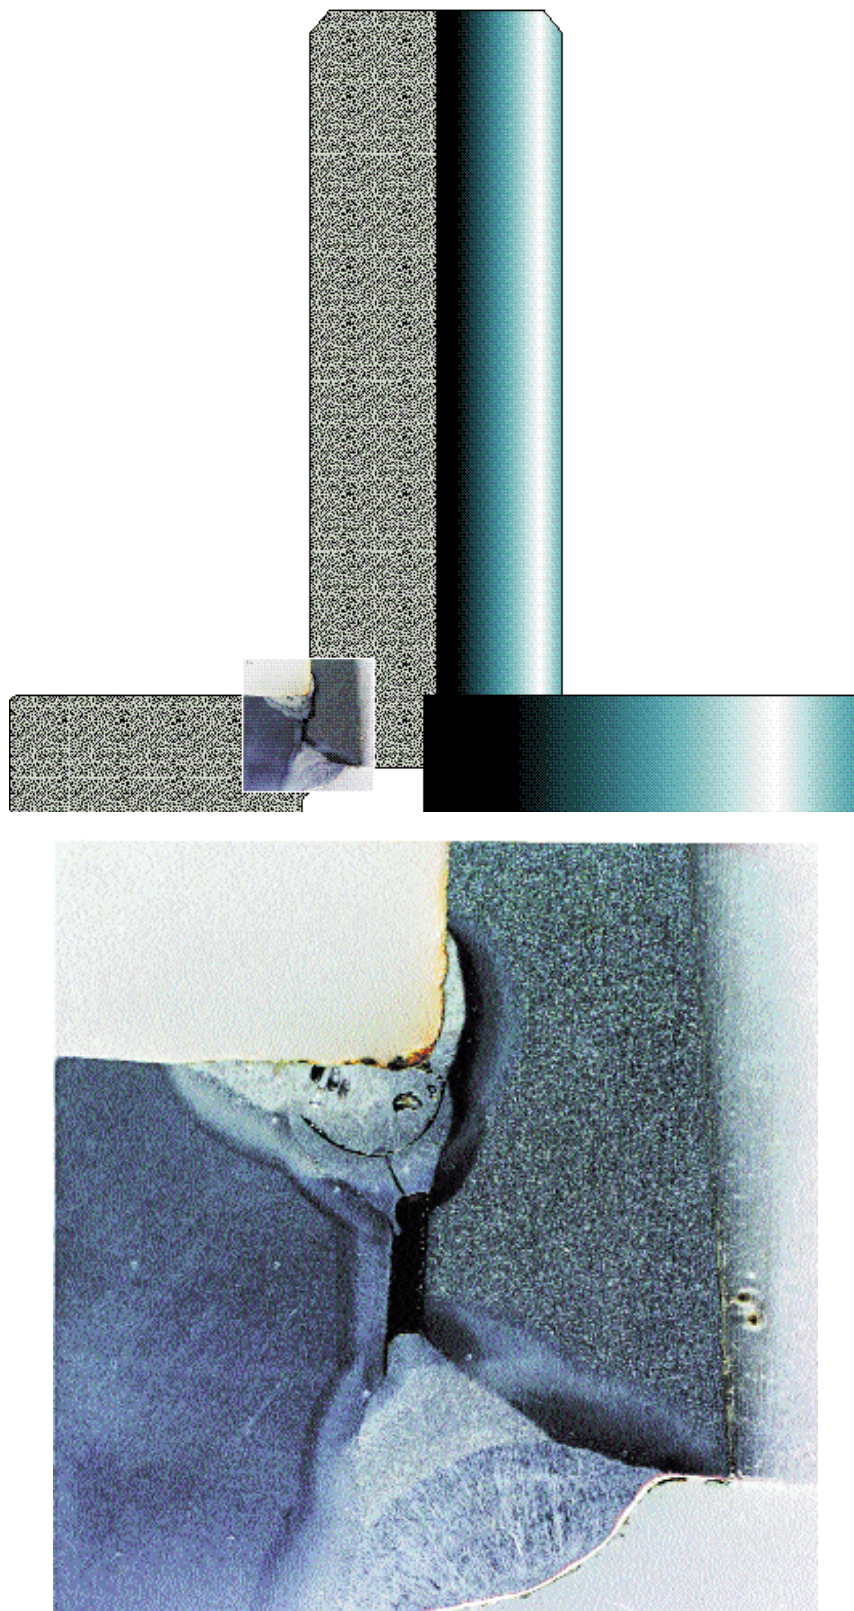
Figure 37: Section through the shore end right stub axle to collar weld with location schematic
