**Temporary Works
forum**

TW22.085 (12.8.22)

Collapse of the Loddon Road Viaduct, 1972 – Fifty Years On

Summary of reports of the failure of falsework for the viaduct over the river Loddon, Berkshire 1972

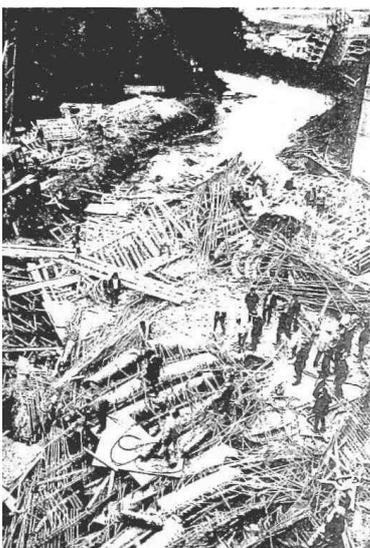
A GENERAL view of the tons of crumbled scaffolding which crashed forty feet into the River Lodon.

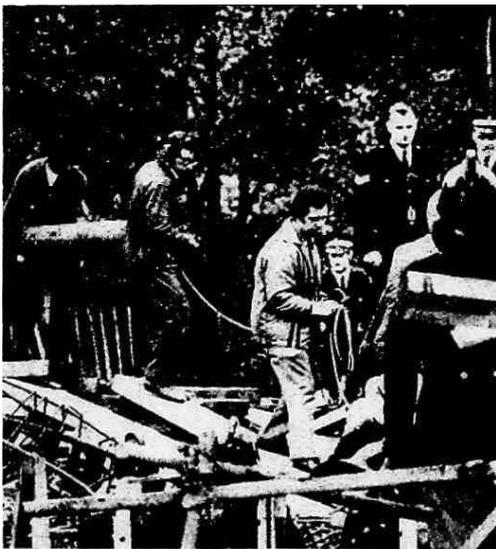
RESCUE workers, police and firemen are sternfaced as the task of pulling away wreckage above the trapped men goes grimly on. A crew with oxy-acetylene burning equipment is seen working in.
