# How Can This Happen?

## Railway Tunnel penetrated by Piles.

**Penetration and obstruction of a tunnel between  
Old Street and Essex Road stations, London  
8 March 2013**

Report 03/2014  
February 2014

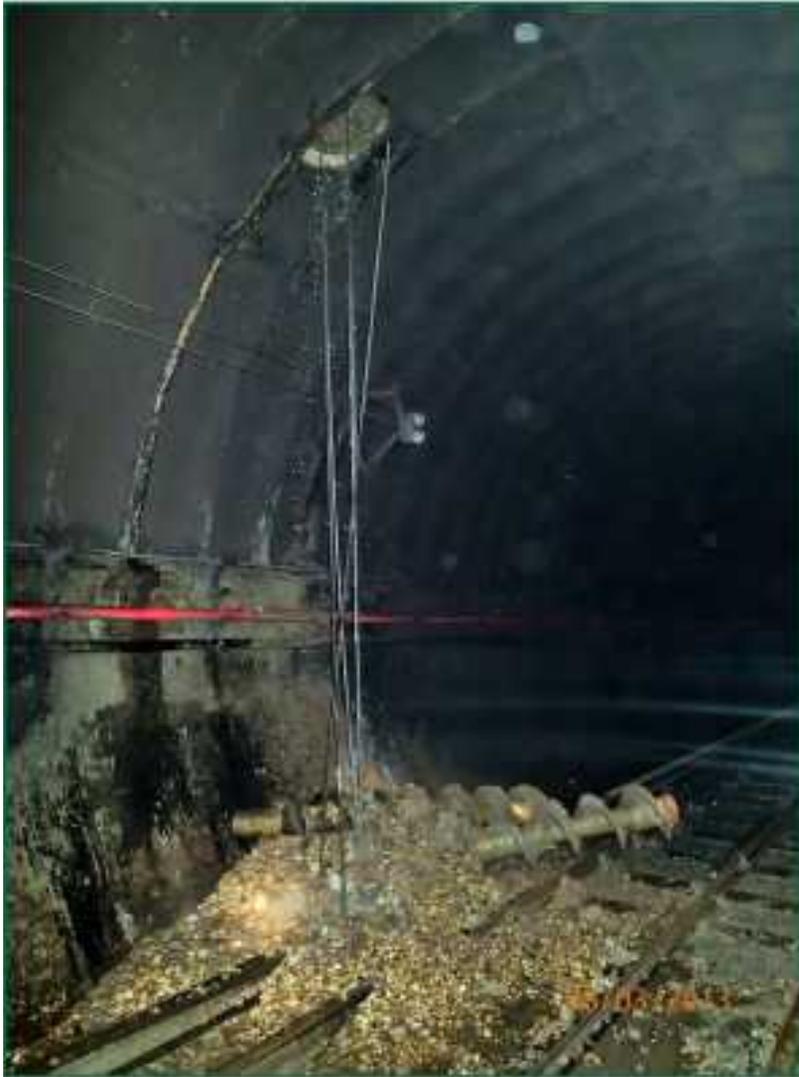
*Figure 5: Penetration of tunnel lining and debris on track*

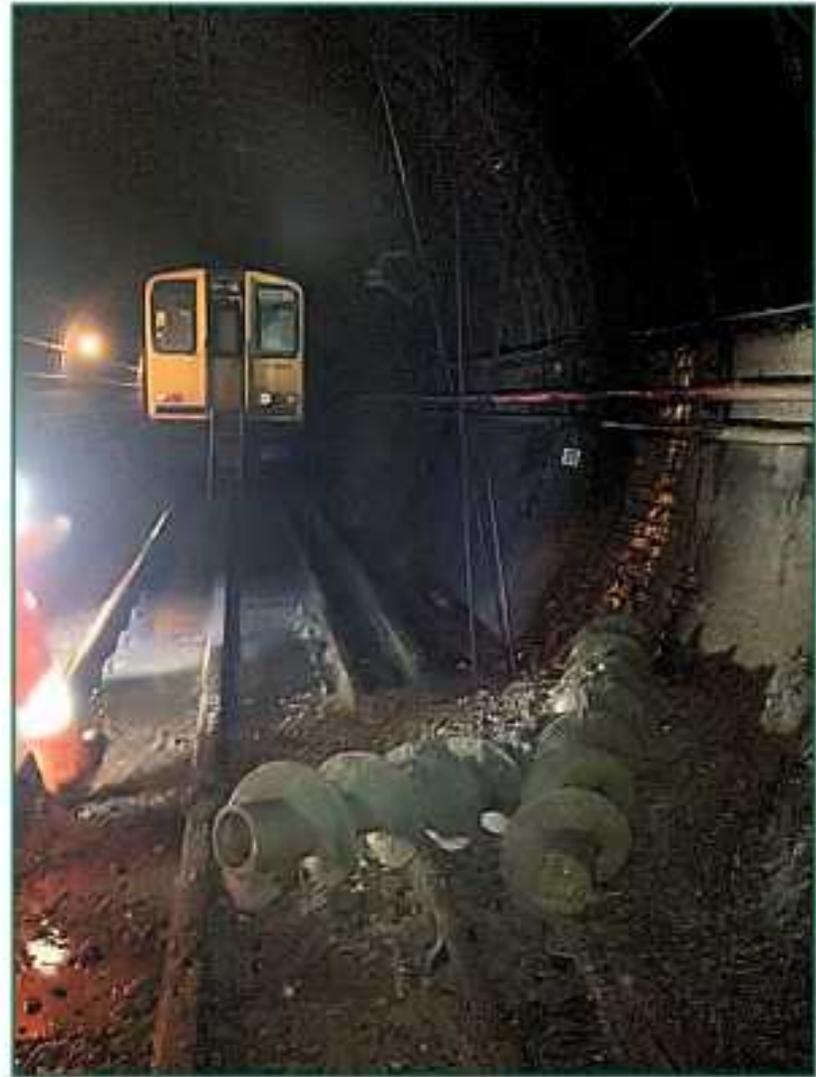
*Figure 6: Auger sections and debris on the track (photograph courtesy of Network Rail)*

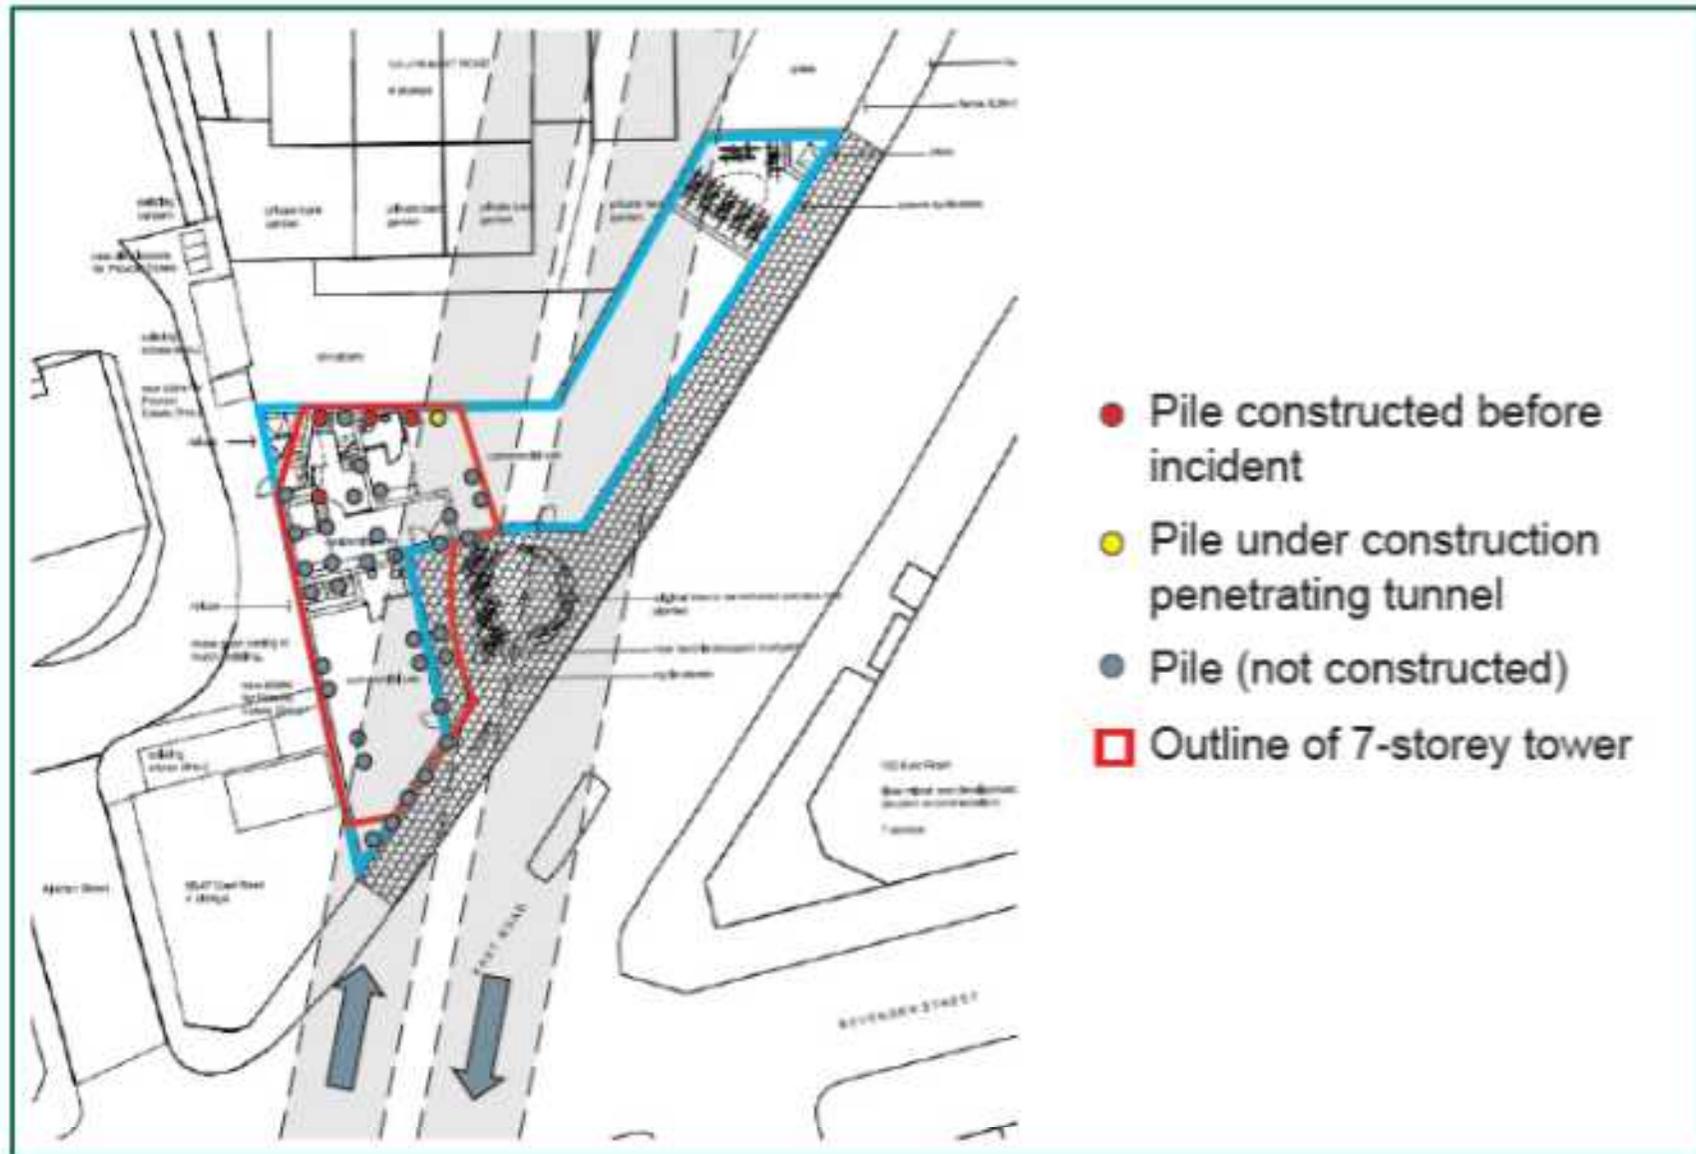
Figure 10: Extract from 2011 planning application enhanced to show location of piles and tunnels

1. The site was vacant since the 1970s.
2. Developer engaged an Architect, Engineer and Land Searches.
3. GI Bore holes done in November 2011 – possible obstructions
4. Planned bore hole depth of 20m, one refused at 14m.
5. The Structural Engineer's research – no tunnels or sewers.
6. Planning permission was granted for the scheme in March 2012.
7. Principal Contractor passed responsibility onto Piling Contractor.
8. Unknown to the designers, 19 of the planned 39 piles would clash.
9. The longest piles would have extended over 9 metres below rail level

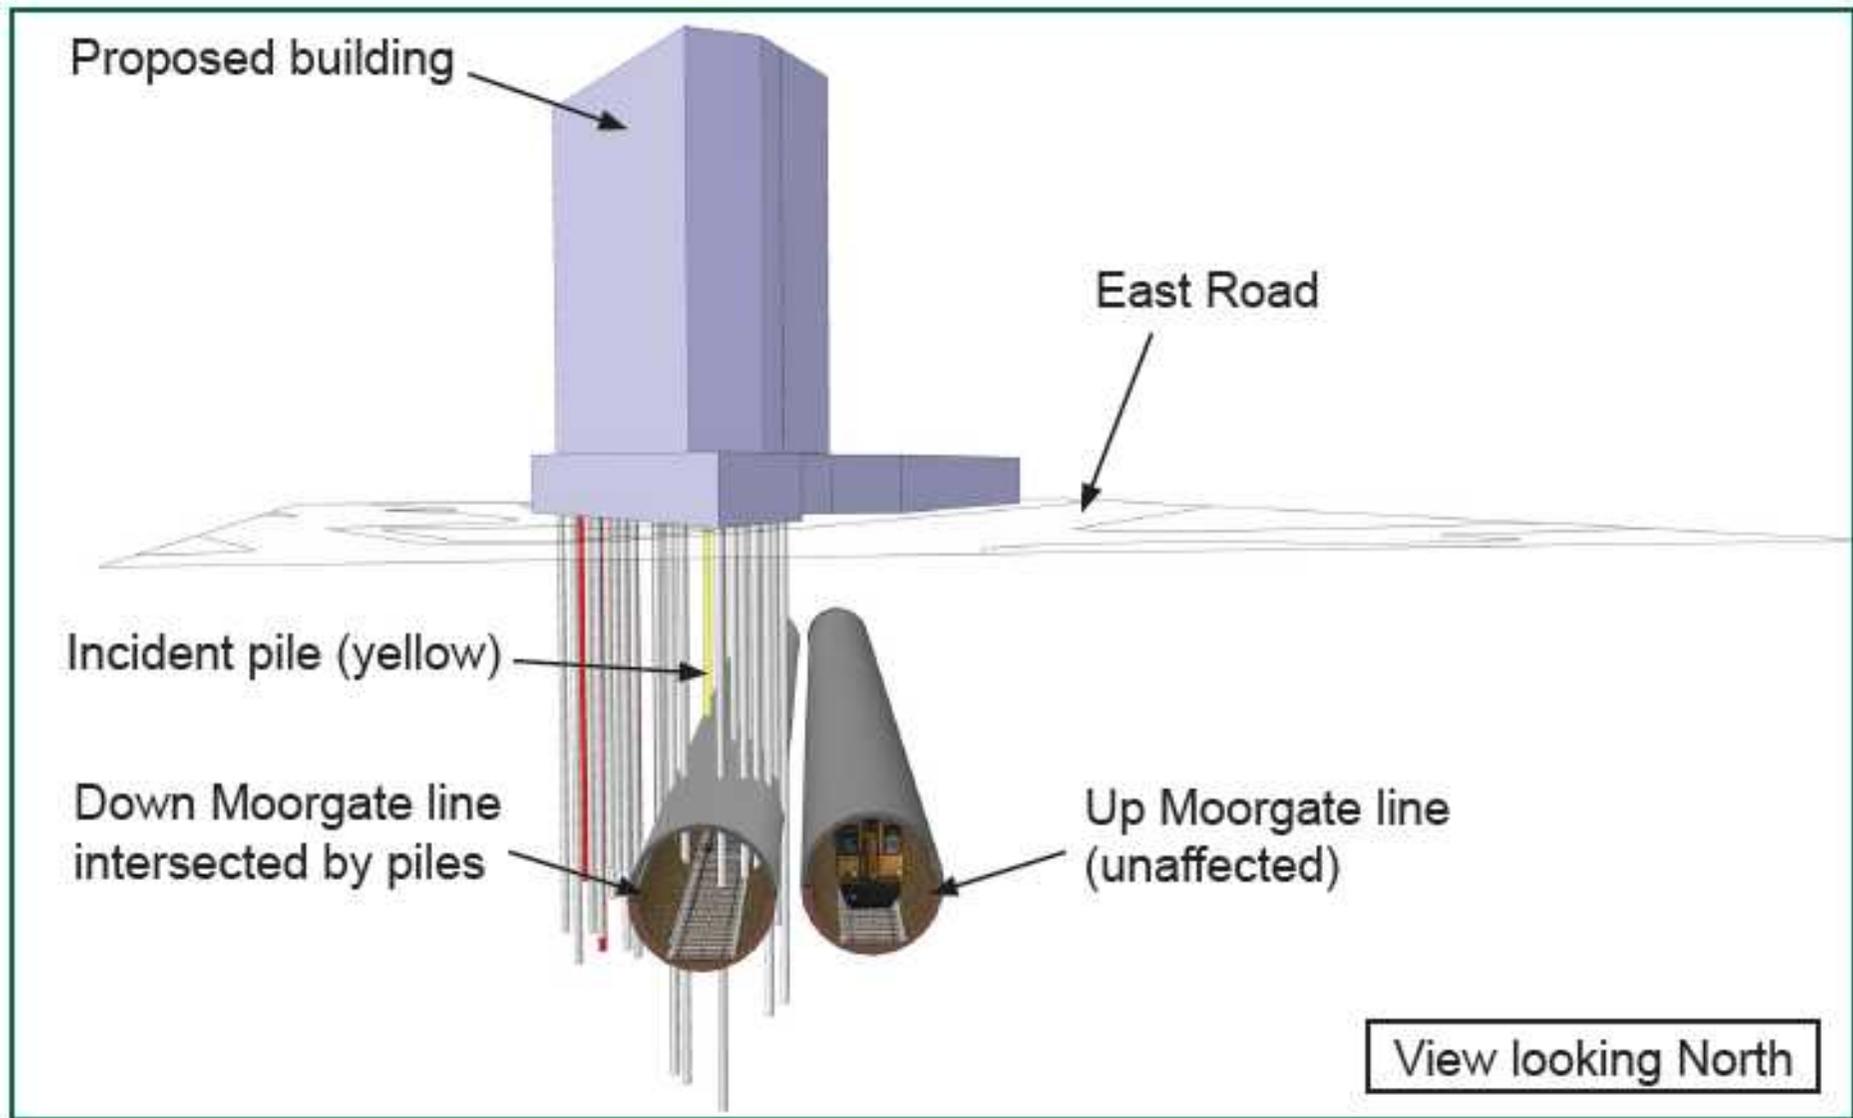
Figure 11: Scale diagram showing proposed foundation layout and extent of interaction with railway tunnel

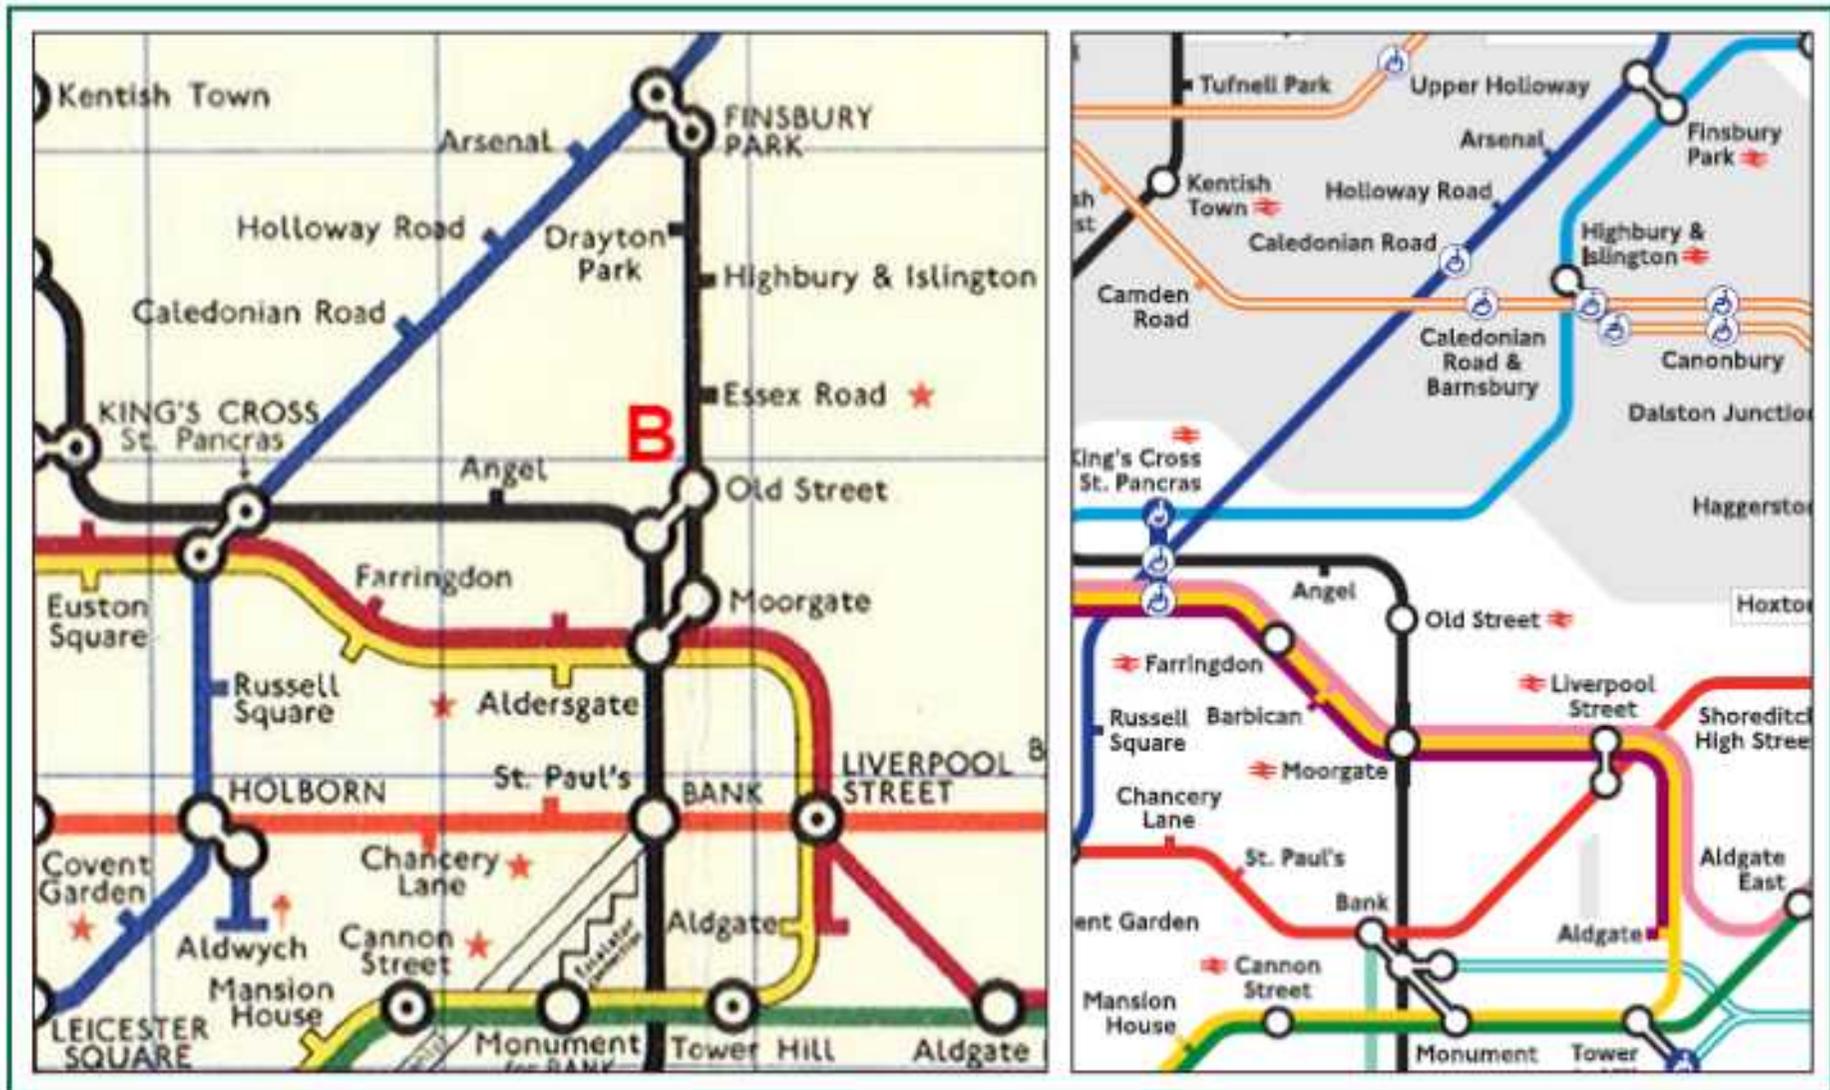
Figures 18 and 19: Extracts from London Underground maps from 1964 and 2013. The Northern City line is shown running between Moorgate and Finsbury Park on the 1964 map (position 'B').

1. In 1967 London Borough of Hackney, intended to issue a covenant.
2. This did not happen and did arise clearly on the land searches.
3. Ordnance Survey do not plot London Underground network.
4. LU originally owned the route and showed it on a 1964 map.
5. LU were not consulted nor a listed of Statutory Authorities.
6. LU transferred the ownership to Network Rail.
7. LU removed the tunnel from their transport map.
8. NR had no protection measures in place and rely upon being informed.
9. NR were not consulted nor a listed of Statutory Authorities.

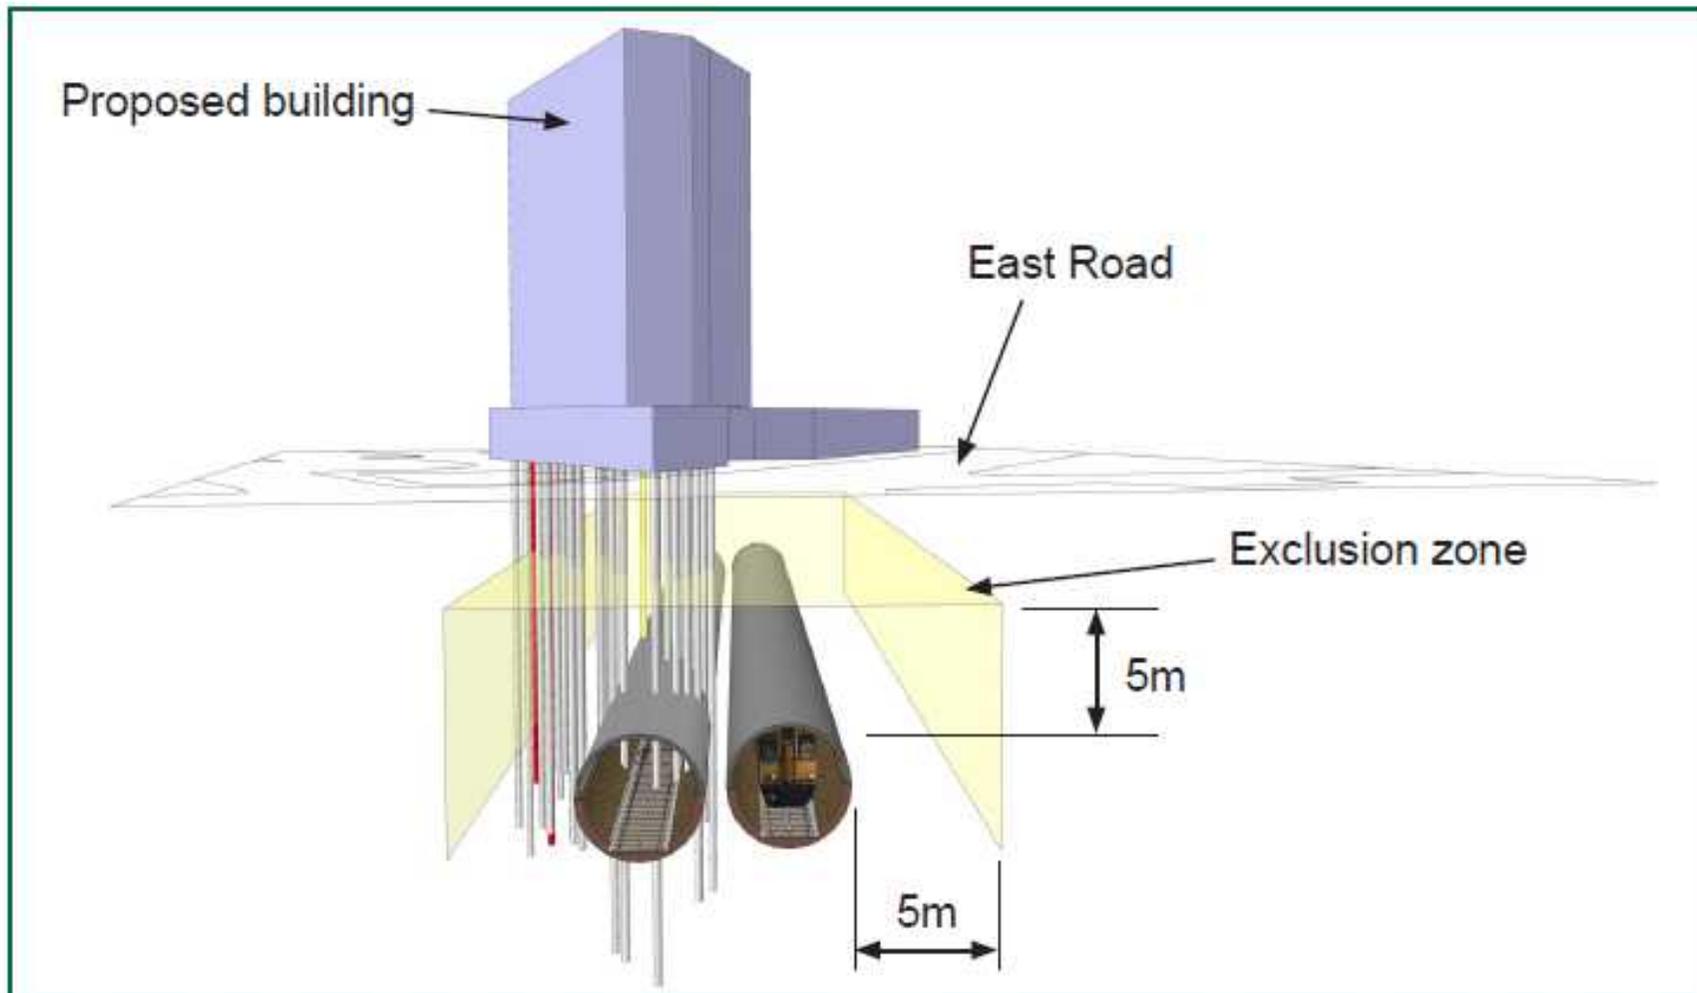
*Figure 20: Scale diagram showing Network Rail's generic piling exclusion zone. Most of the proposed piles are located within this zone.*
