Walkway collapse at

PORT RAMSGATE

A report on the investigation into the
walkway collapse at Port Ramsgate on 14
September 1994

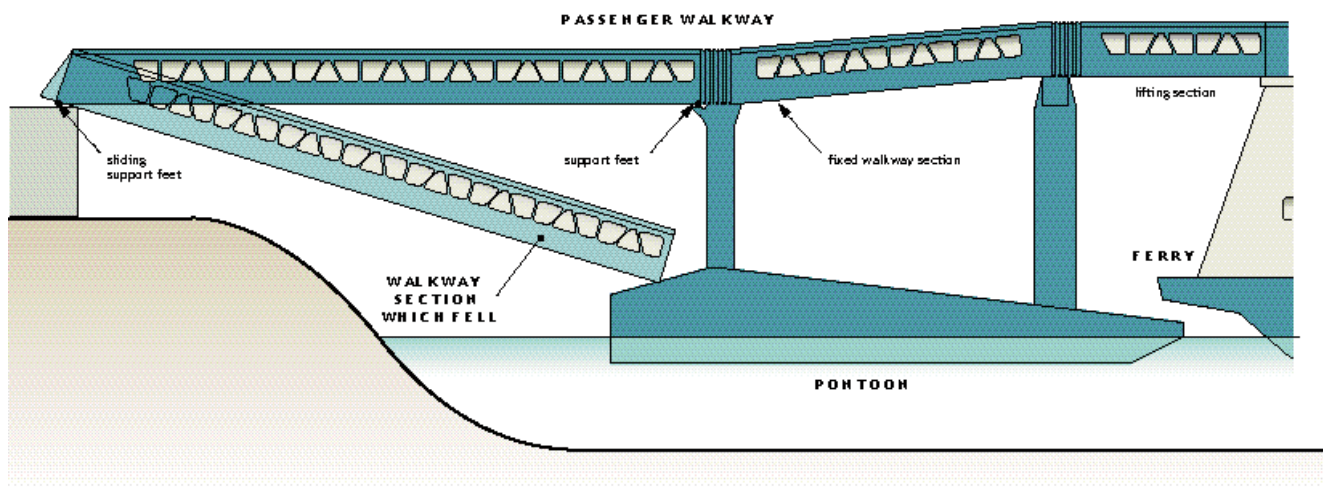
Figure 2a: Diagram showing the walkway from shore to ferry

- 3 The end of the section leading from the shore to the pontoon fell when its only secured connection to the pontoon portal frame failed (see Figures 2a and 2b). This section of the walkway had been supported using four stub axles, one welded to each corner of the walkway. Each stub axle rested in a bearing sleeve that formed part of a support foot. The four support feet were designed to rotate on the stub axles and were of the same design, with the following exception: the seaward right-hand support foot (viewed along the walkway from the shore) was attached to the walkway support platform on which the feet rested at the pontoon end by a vertical pintle. The other three support feet rested on flat support surfaces and had been designed to slide as the pontoon moved relative to the shore. The two at the shore end rested in slideway guides.

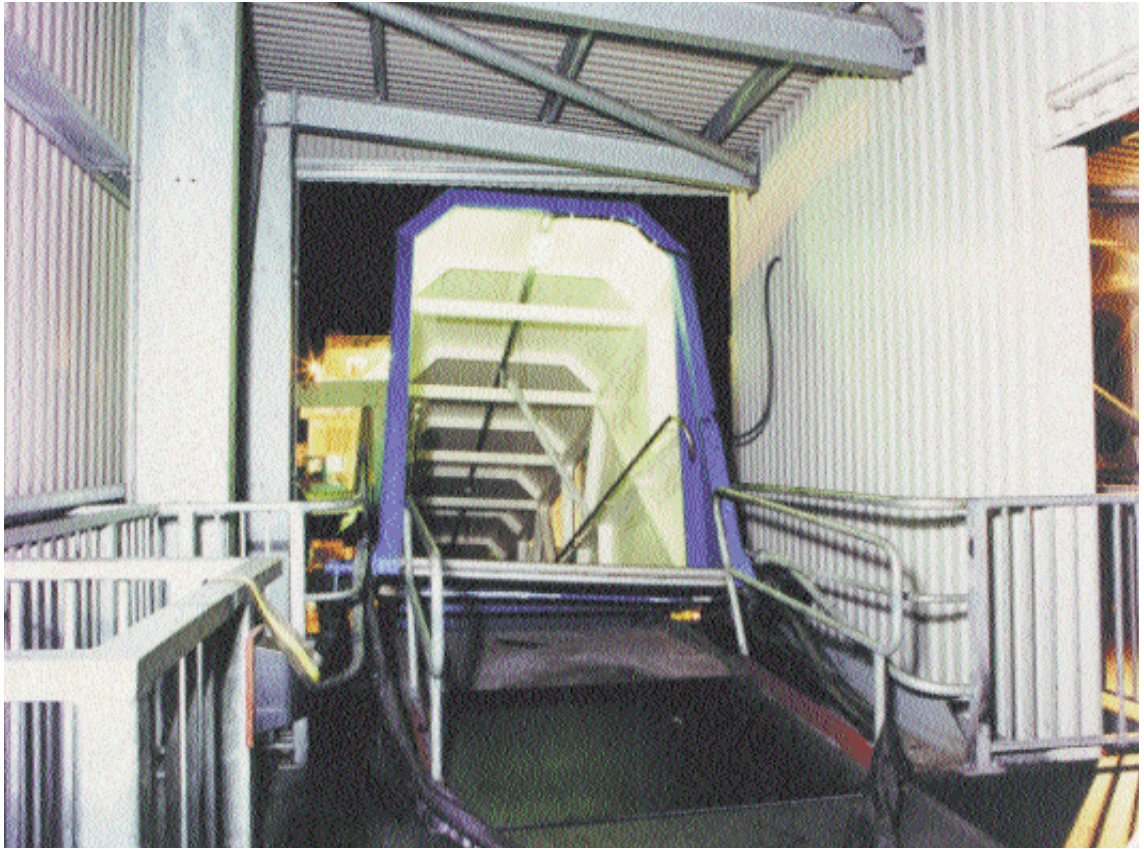
Figure 5: Shore end of collapsed walkway photographed from inside passenger ramp building

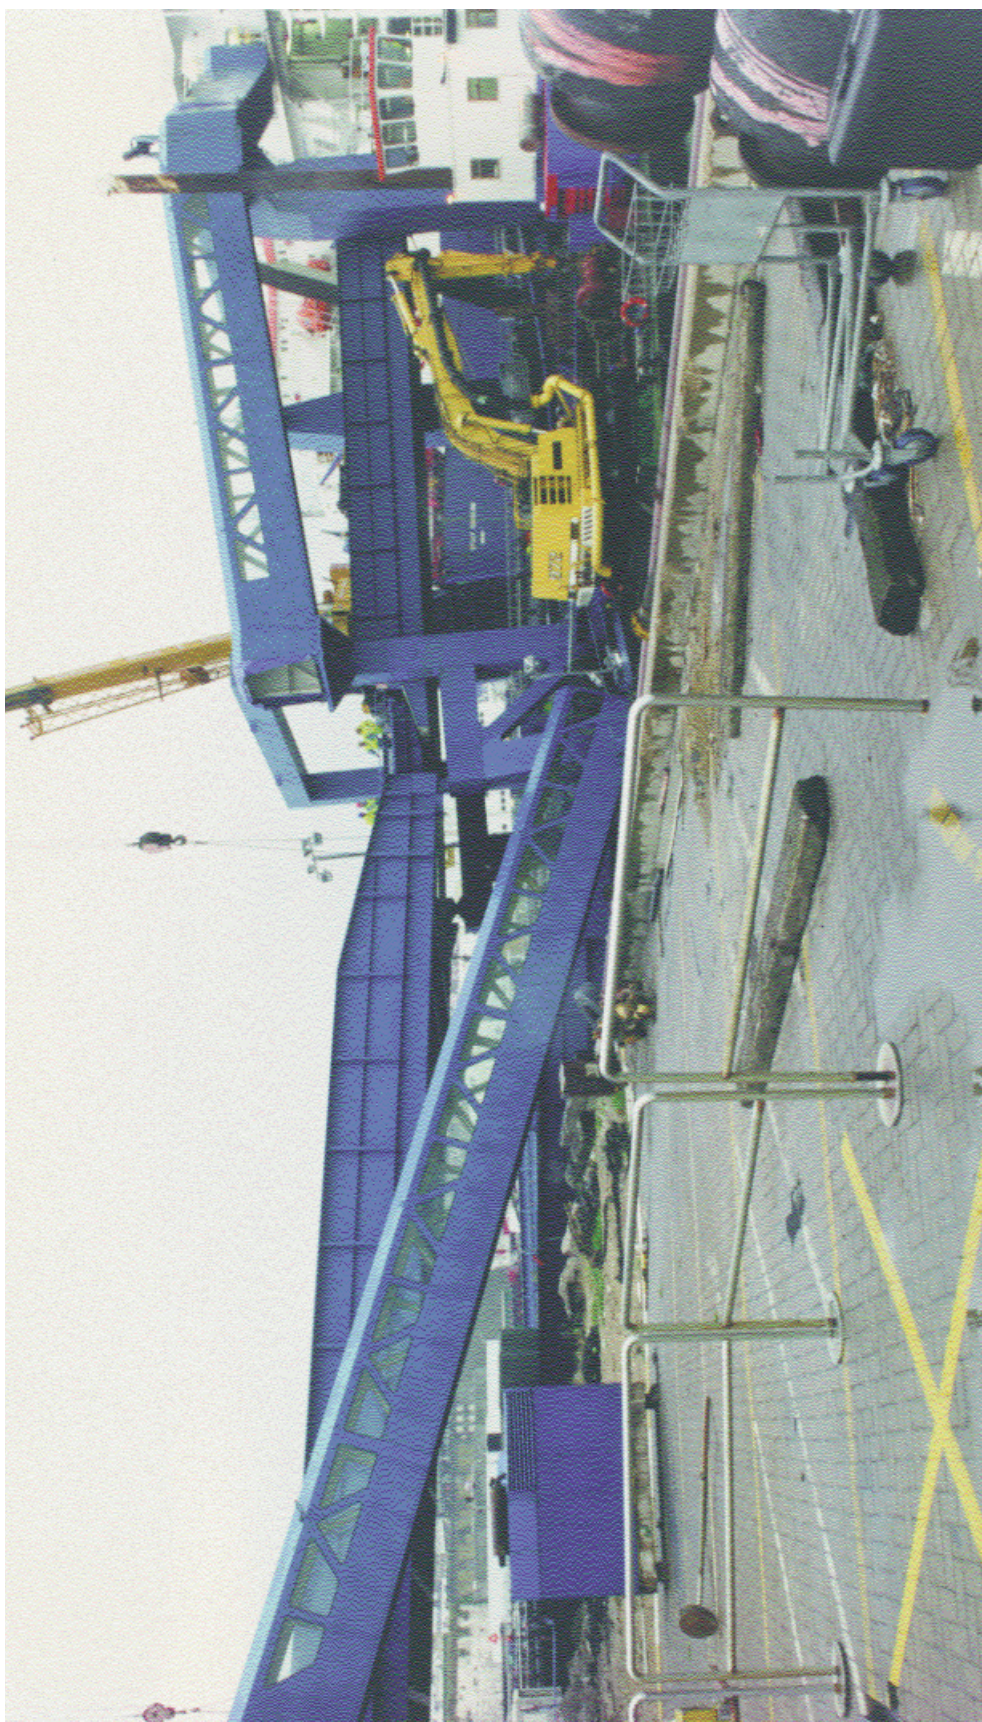
Figure 10: Berth 3 from south west - walkway span in fallen position

- 43 After the collapse, the walkway was resting in a precarious position and there was a risk of further collapse and damage. Two mobile cranes were used to support the fallen section during initial investigation (see Figure 10) then to recover and place it on the upper vehicle bridge. Parts of the walkway were identified for further detailed examination, marked, cut away from the structure and placed in secure storage. Viewed from the shore, the support feet at the pontoon end were called the 'seaward left' and 'seaward right' feet. Those at the shore end were called the 'shore end left' and 'shore end right' feet. The seaward right foot is the one with the vertical pin or 'pintle' that attached the walkway to the pontoon.

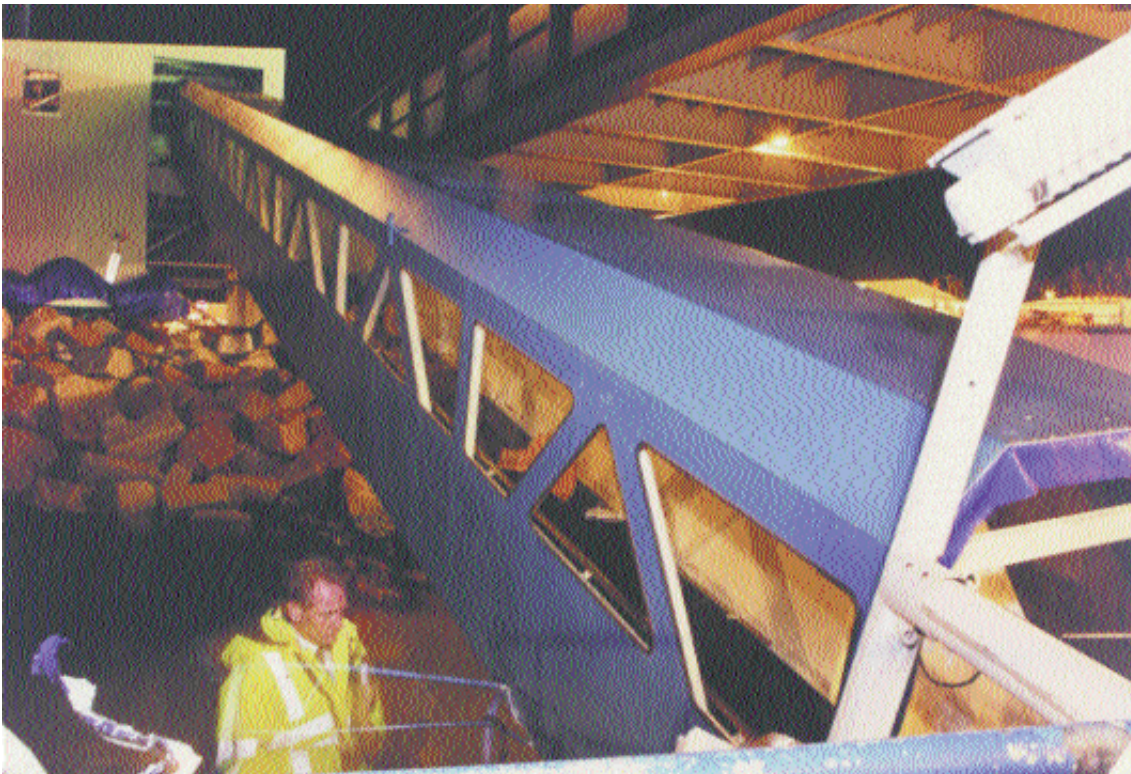
Figure 11: Collapsed walkway from pontoon deck

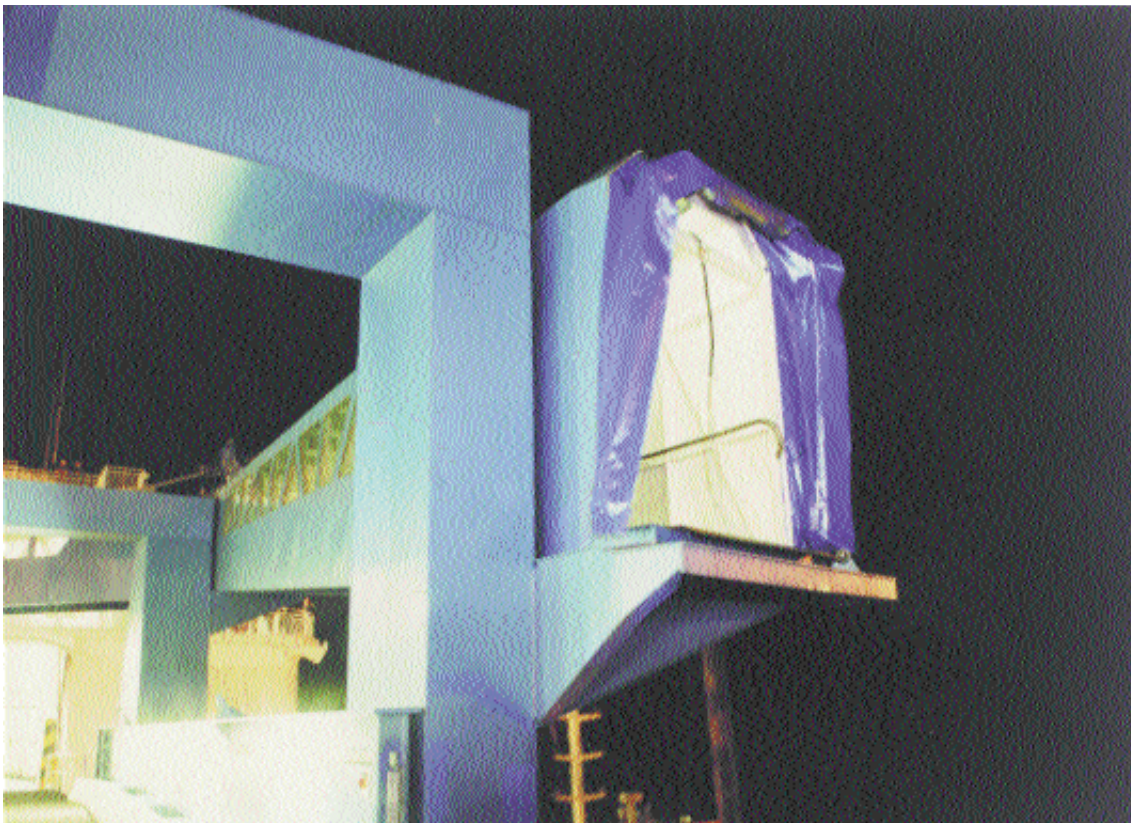
Figure 12: Pontoon support platform and fixed section of walkway

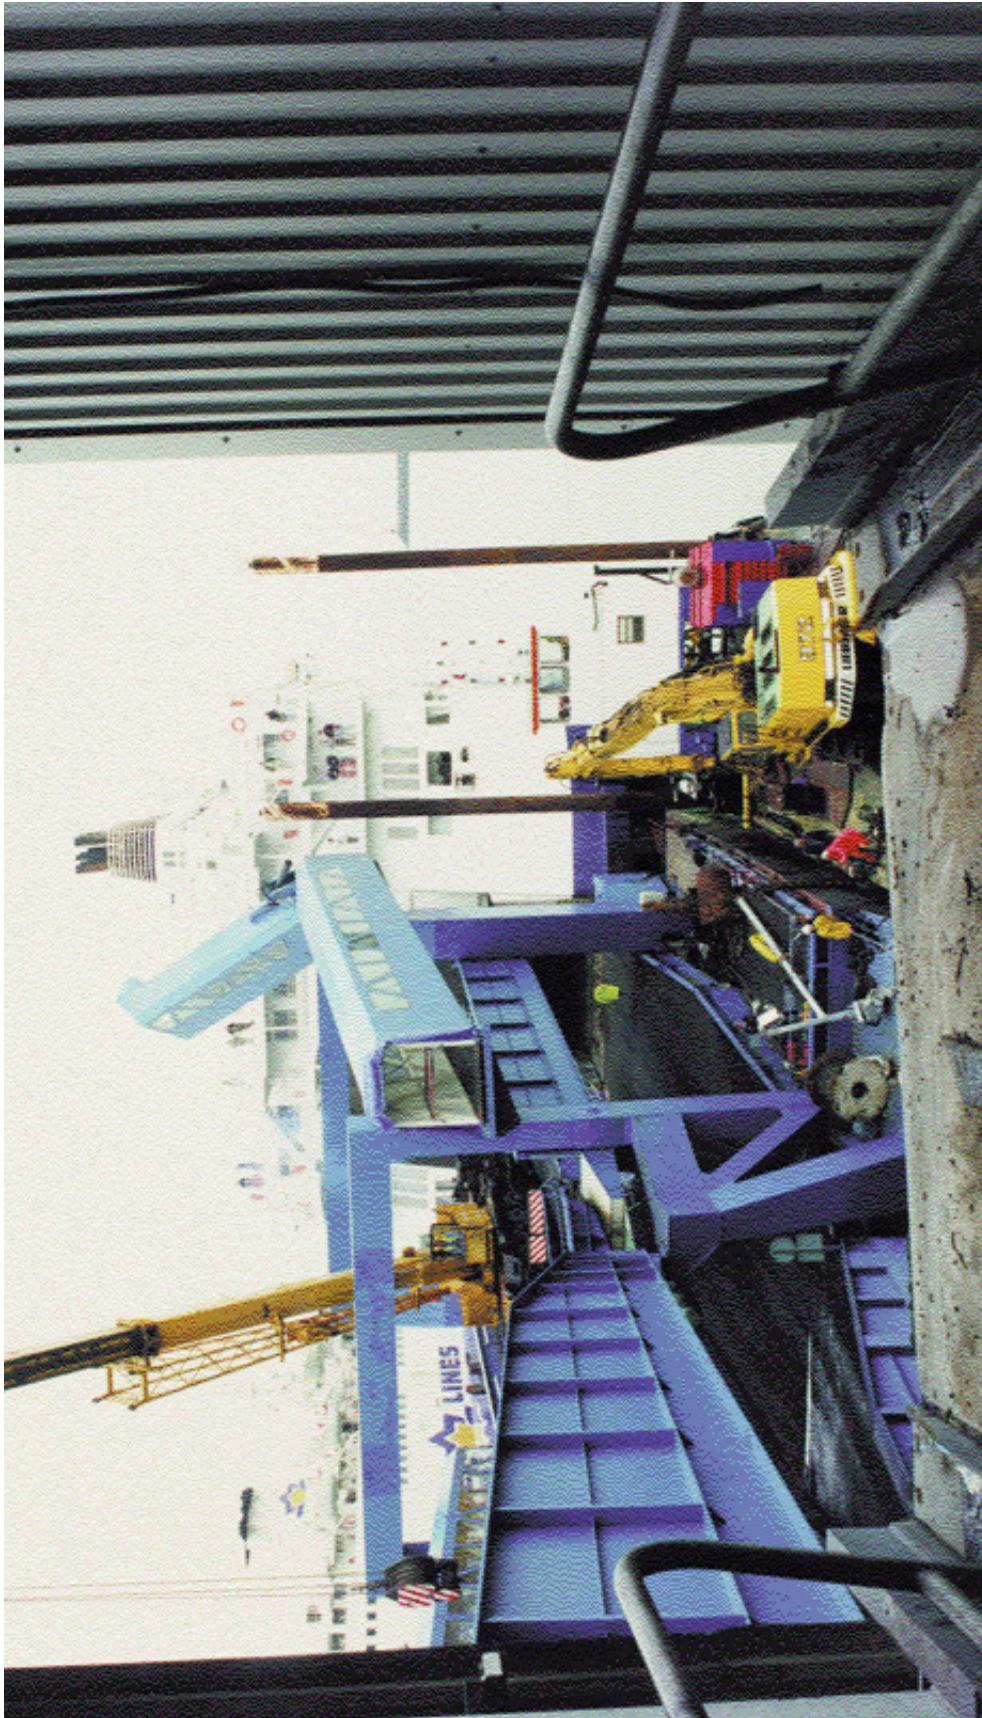
Figure 13: The gap the walkway spanned to the pontoon - and showing ends of passenger ramp slideways

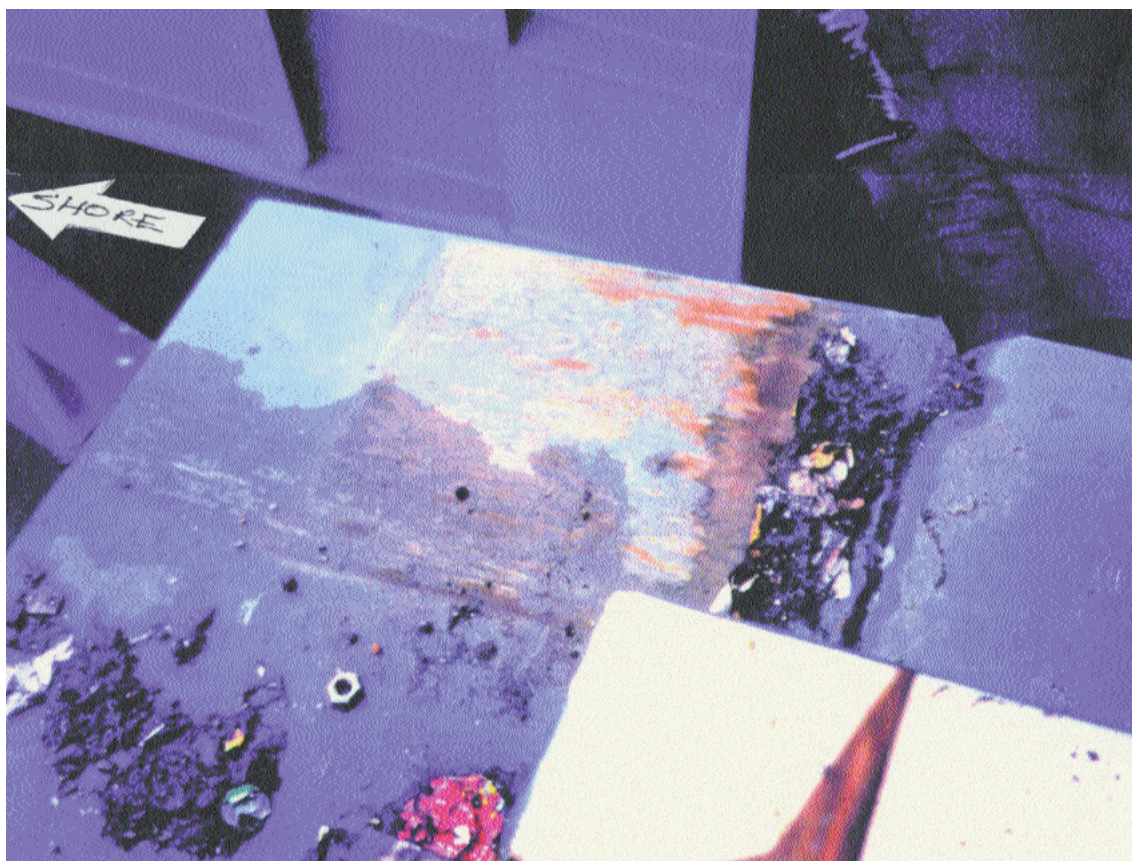
Figure 18: Support platform showing position of seaward left-hand foot assembly

allow for pontoon movement. The painted finish below the low-friction contact area was also much worn away and the base metal rusted, especially on the seaward edge of the contact zone. Figure 18 is a photograph taken the day after the accident, showing the top left contact area of the support platform.

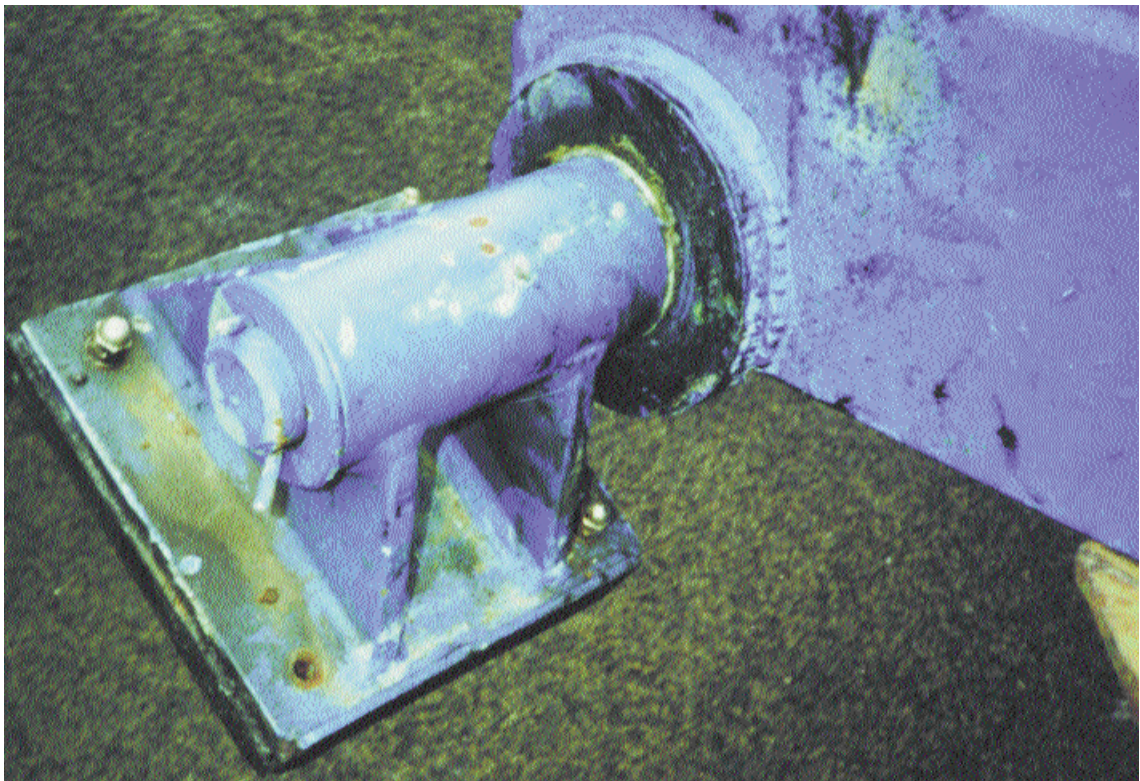
- 50 The seaward left stub axle was seized within the support sleeve. Figure 19 shows the failed seaward left stub axle protruding from its support foot. Dismantling required machining the support sleeve into two pieces to free the stub axle. The grease distribution groove at the bottom of the sleeve bore was found to be completely blocked with rust and metal debris. Despite its immersion in sea water, it is likely that the seaward left support foot was not rotating on its stub axle before the accident.

Figure 19: Shore end right support foot still attached to walkway

- 4 Failure of the seaward left foot assembly had occurred as a result of the separation of the stub axle from the collar. The collar remained in position, welded to the walkway structure. The fracture surface on the stub axle is shown in Figure 19.

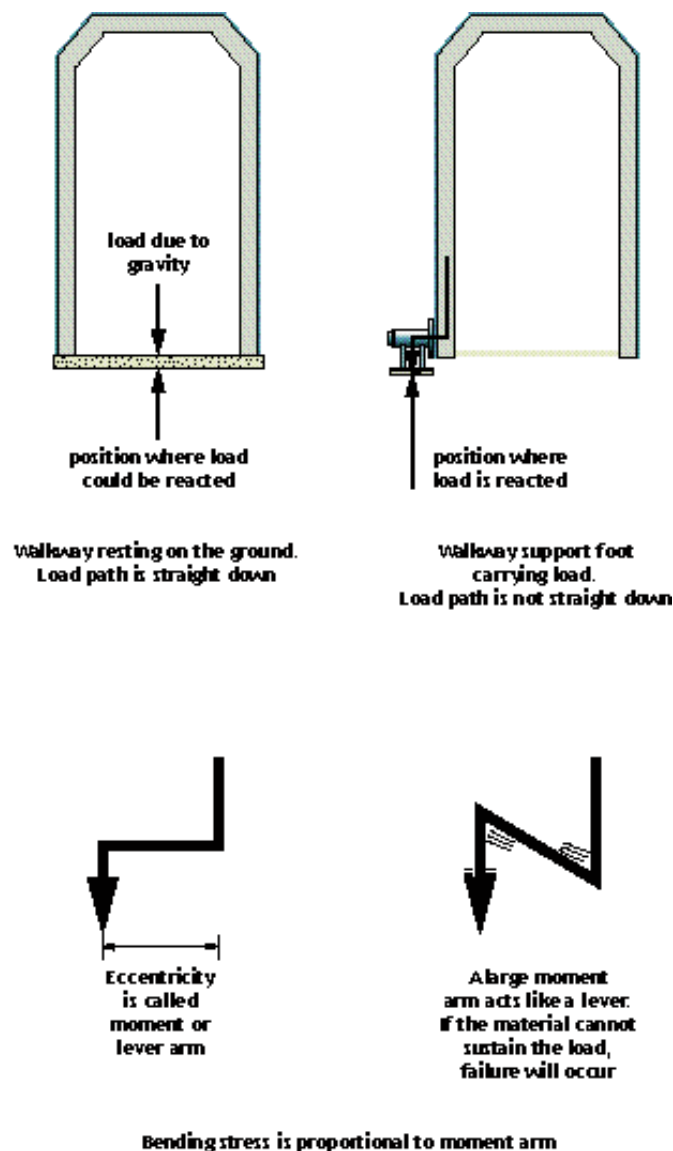
- (e) The support feet were cantilevered from the walkway sides and the load path would not be in a simple vertical line. The load acted on the stub axle/collar joints to create a bending force, so that the stress was increased in proportion to the length of the stub axles acting as a lever (known as the moment arm). Figure 27 illustrates the concept of a 'load path'.

Figure 27: The concept of load path eccentricity and moment arm

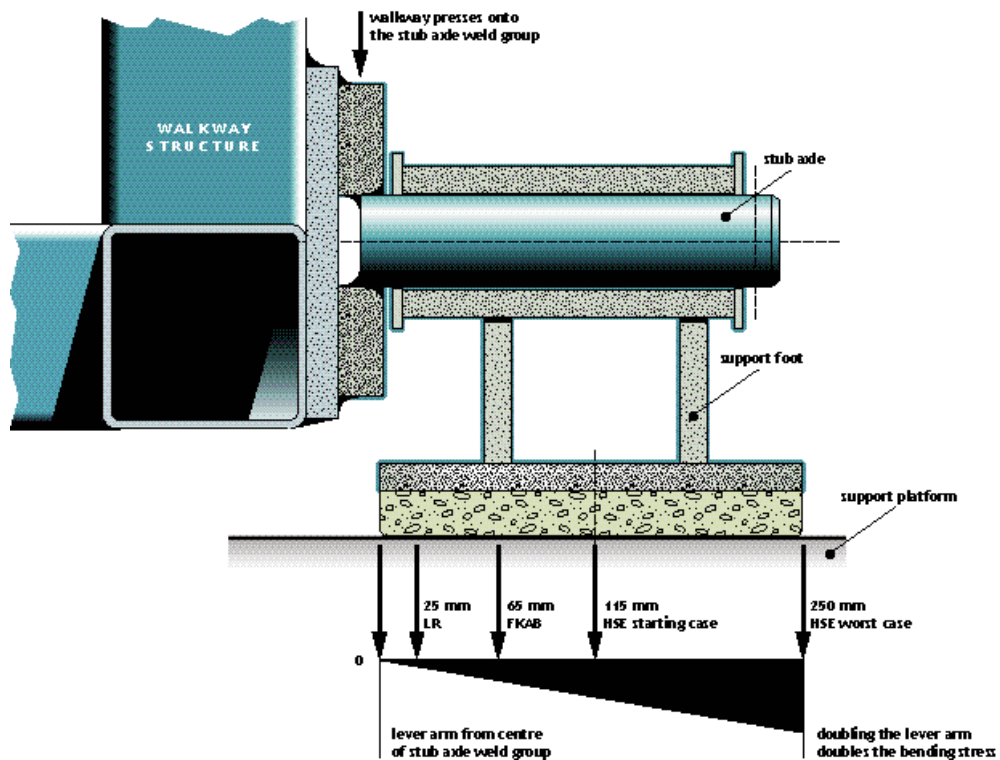
- 70 The FKAB and LR calculations suggest that both the designer and those checking the design had difficulty visualising the structure and how it would be subjected to dynamic loading. In particular, FKAB failed to realise that the support feet and axle bearing sleeves would tilt under static and dynamic stresses and this would result in a variable length of axle moment arm (see Figure 28). FKAB apparently assumed a 65 mm moment arm. LR seriously erred in considering the moment arm and assessed it as 25 mm although the assumption on which this was based was not given. **No fatigue calculations were made by FKAB or LR.**

Figure 29: Stub axle lever arm load path through support foot
