**Temporary Works
forum**

TW22.085 (12.8.22)

Collapse of the Loddon Road Viaduct, 1972 – Fifty Years On

Summary of reports of the failure of falsework for the viaduct over the river Loddon, Berkshire 1972

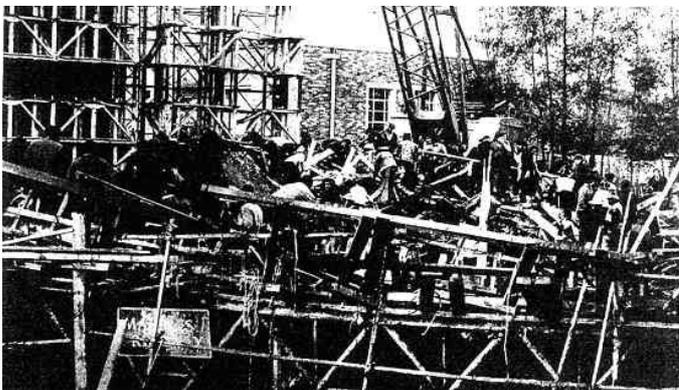
This was the scene at the Loddon Bridge disaster on Tuesday when three men died and 10 were brought out injured after being trapped in the tangled mesh of girders, rods and splintered wooden frames. Hundreds of tons of concrete, wood and steel had crashed 40ft down when the span between two concrete pillars was on the point of being cemented.

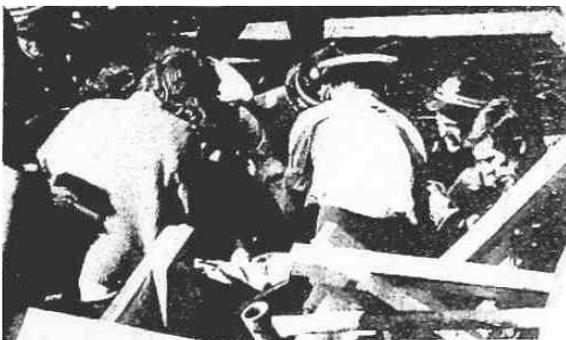
WILLING hands pull out an injured workman. There were more willing hands ready to put the injured in ambulances and rush them off to hospital.

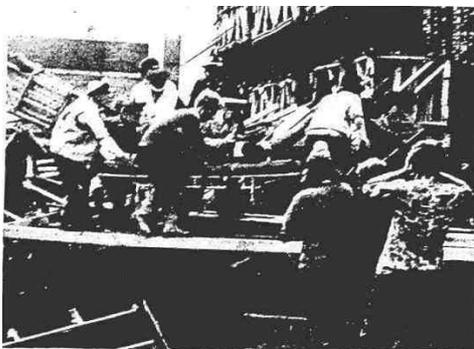
WEARY rescue workers carry out one of the badly injured on a stretcher to a waiting ambulance as some of the man's mates stand-by. One holds his hands to his head in horror as he discovers the identity of the victim.

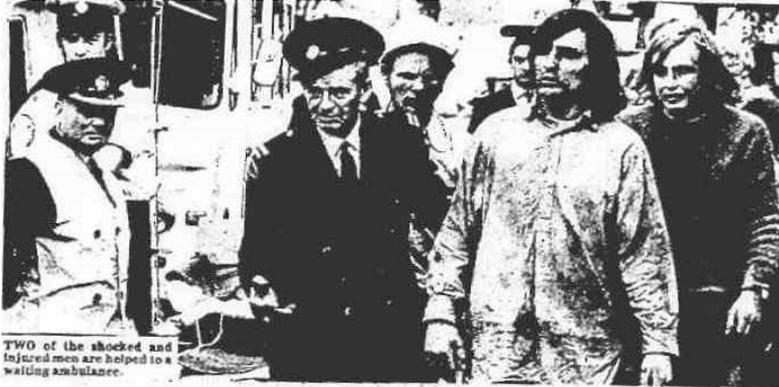
TWO of the shocked and injured men are helped to a waiting ambulance.

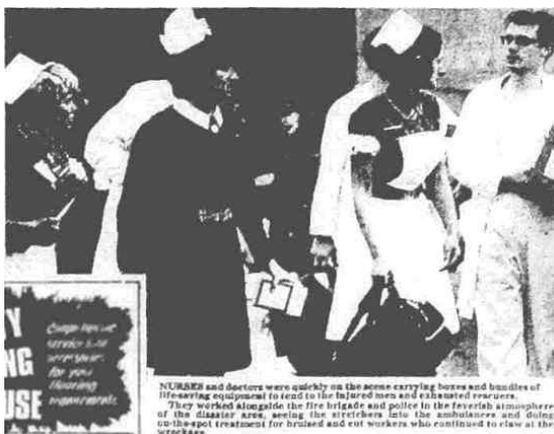
NURSES and doctors were quickly on the scene carrying boxes and bundles of life-saving equipment to tend to the injured men and exhausted rescuers. They worked alongside the fire brigade and police in the feverish atmosphere of the disaster area, seeing the stretchers into the ambulances and doing on-the-spot treatment for bruised and cut workers who continued to claw at the wreckage.
